## **2016 APC-Wastewater Round Table & Expo Presentation**

# Wet FGD Operations and Lessons Learned

Joe Mitchell, *Environmental Process Engineer*

# WFGD Operations and Lessons Learned – Monroe Station

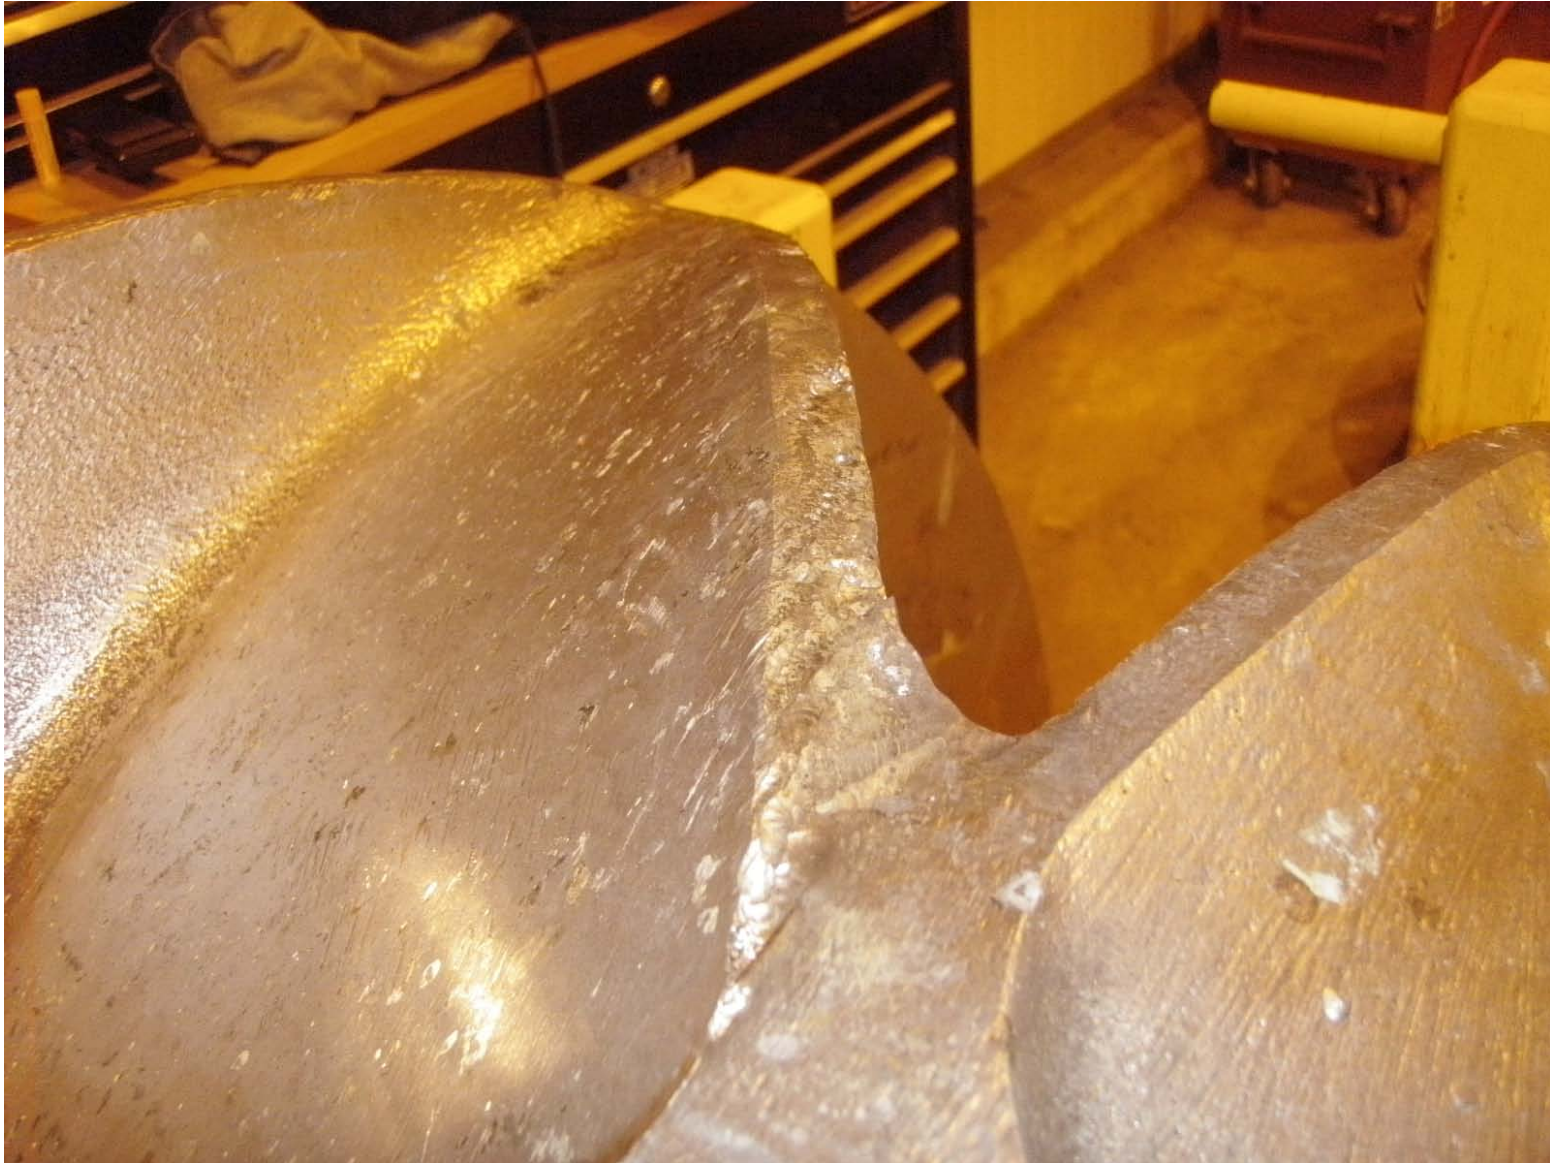
# AR Pump Impeller Wear

- **Erosion of frame plate rubber liner insert**
- Severe enough to cause liner failure
- Slurry migrated behind liner
  - Corrosion of pump casing
- ▶ Original pump design used
  - Flush-less mechanical seal, Burgman 03-HR321/165-G1-E4
- **Rubber pieces from liner plugged AR spray nozzles**
- Reduction in SO<sub>2</sub> removal capability observed
- **Erosion/Corrosion of Impeller**

- **Replaced Impellers and Throatbush**
  - Cast alloy material
- **Added ceramic adapter plate behind impellers**
- **Added flush water to mechanical seals**
  - Approximately 10 gpm at 140 psig
  - Erosion rate decreased by pressurizing the area behind impeller
- **Achieved 3 year run time after modification**

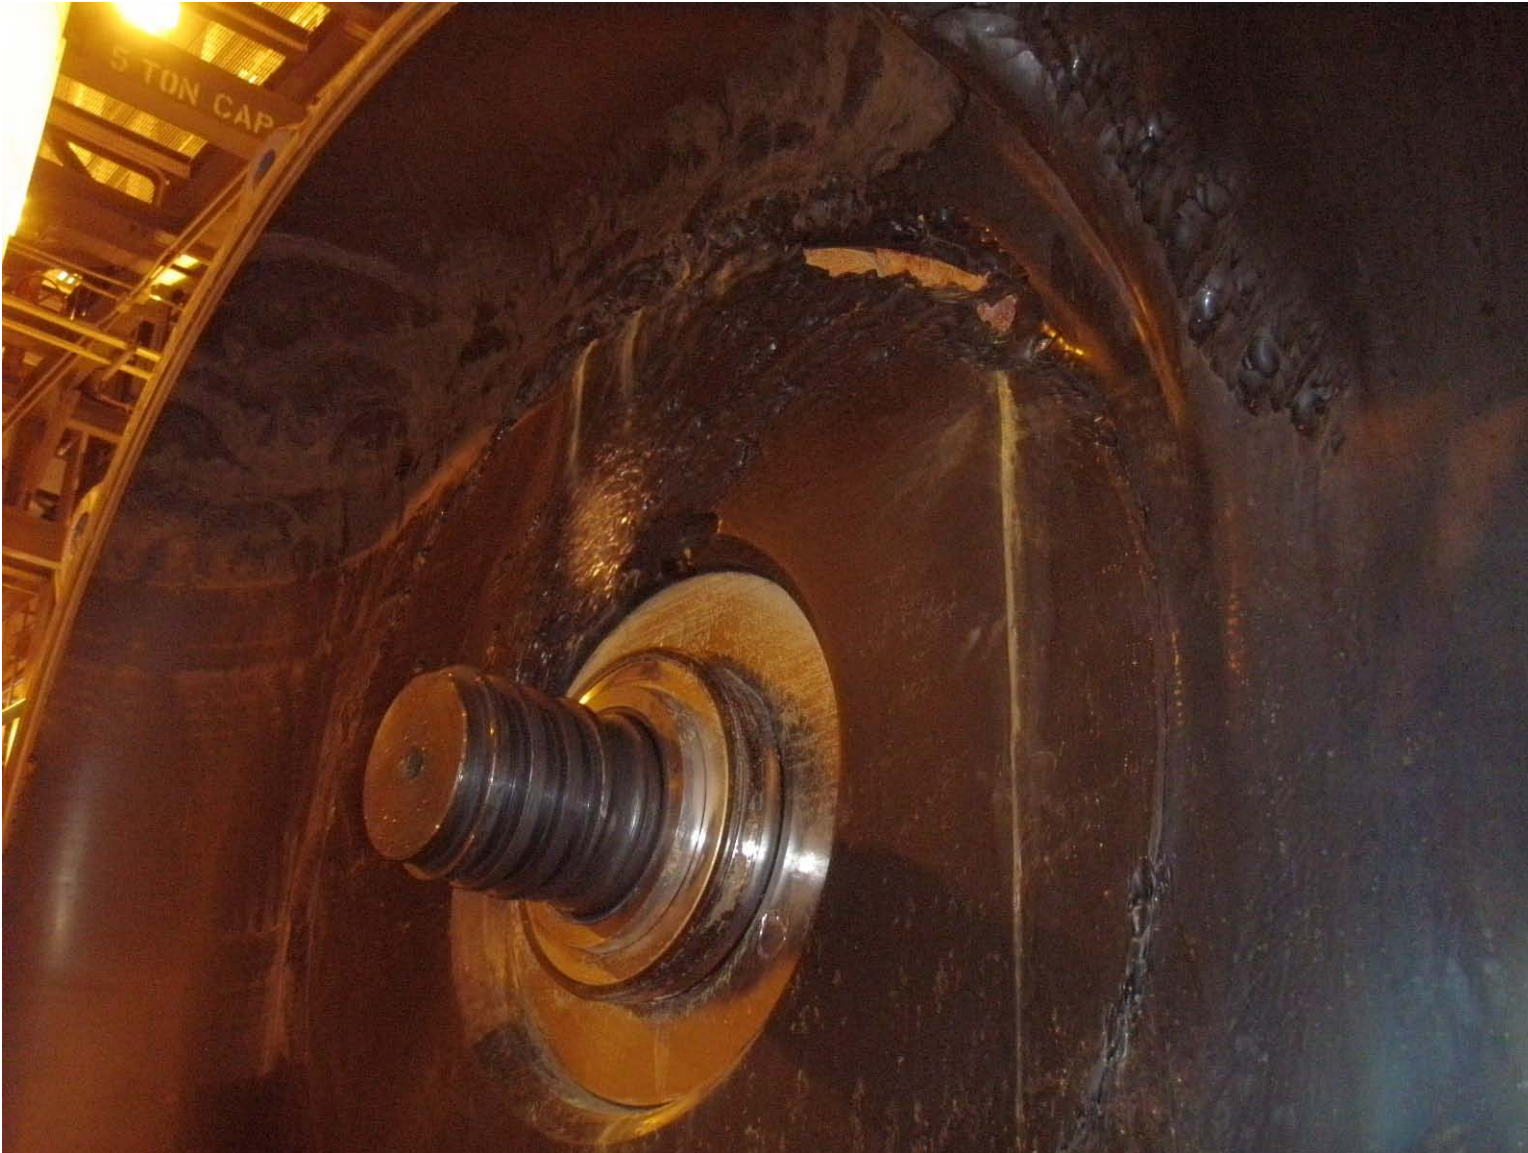
# AR Pump Rubber Liner Failure

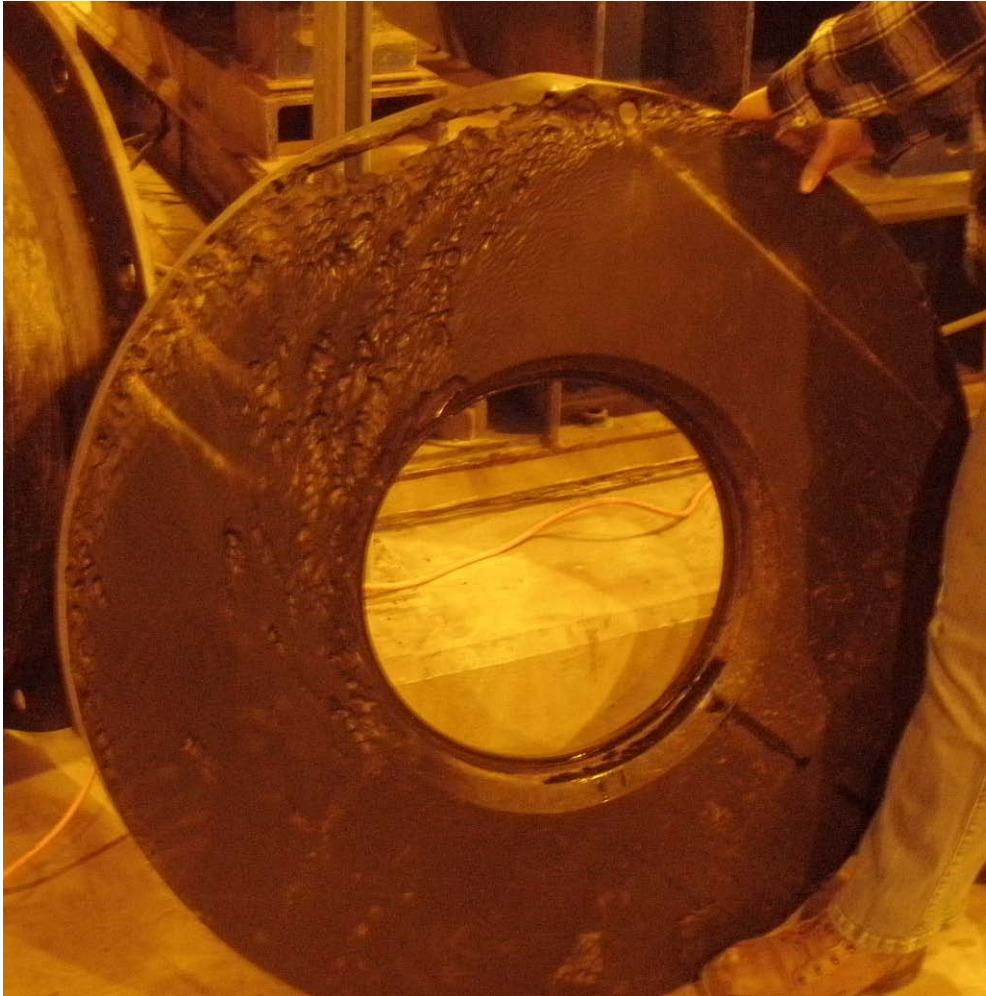
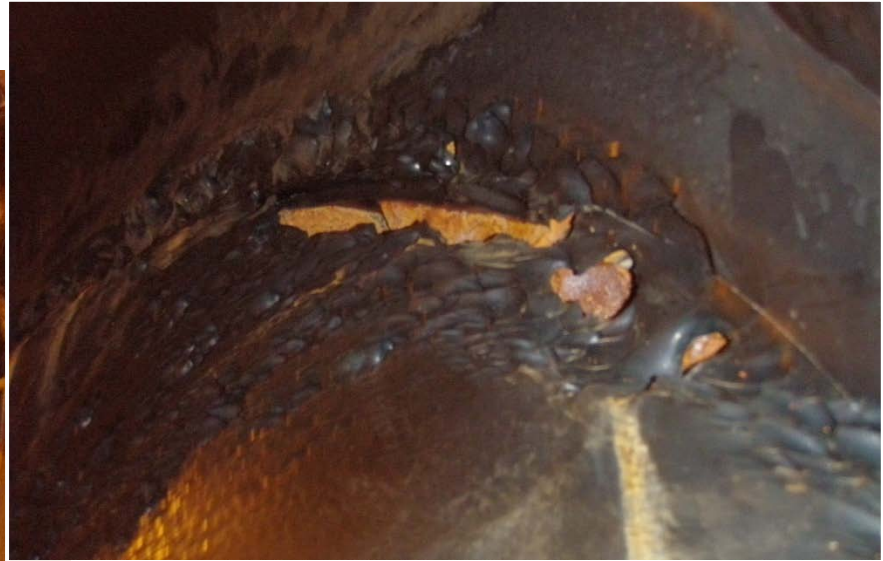
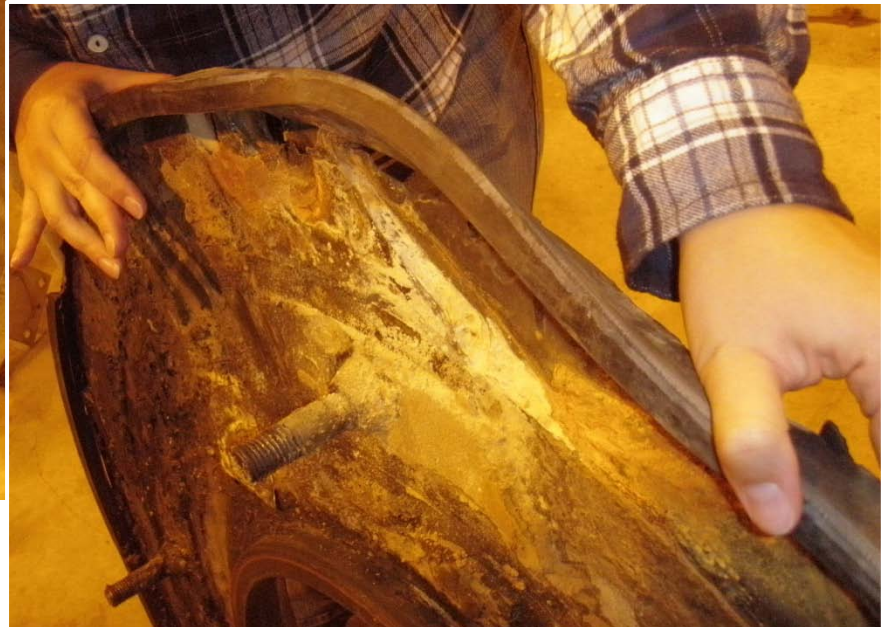
# AR Pump Rubber Liner Failure

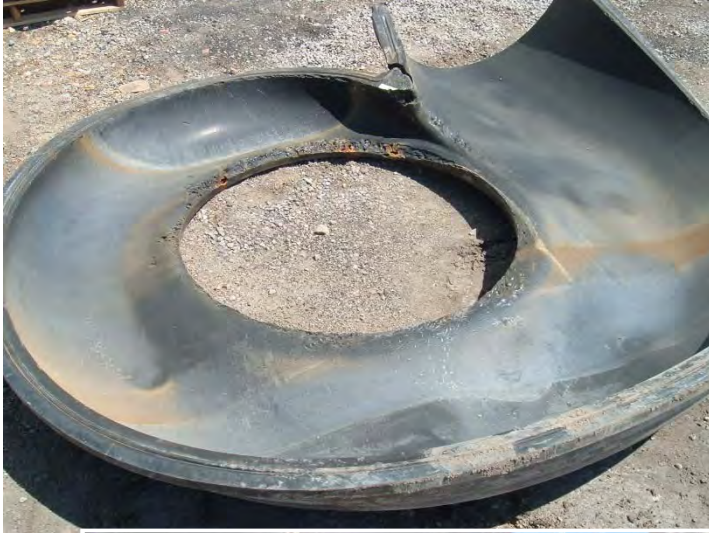
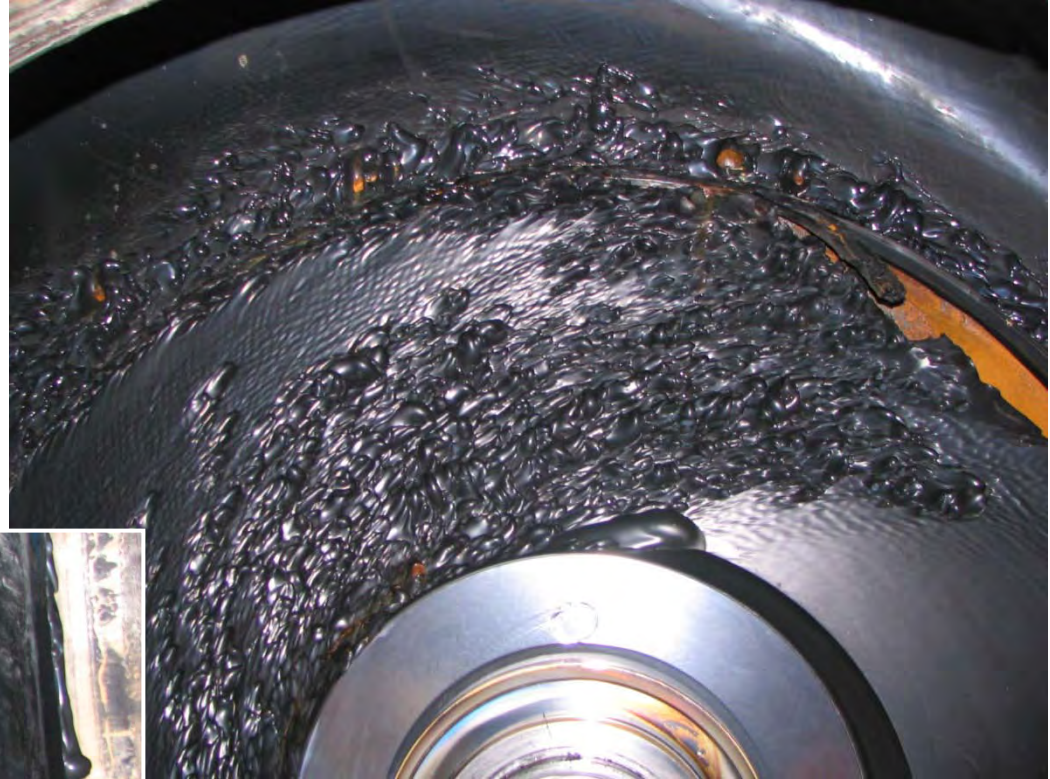
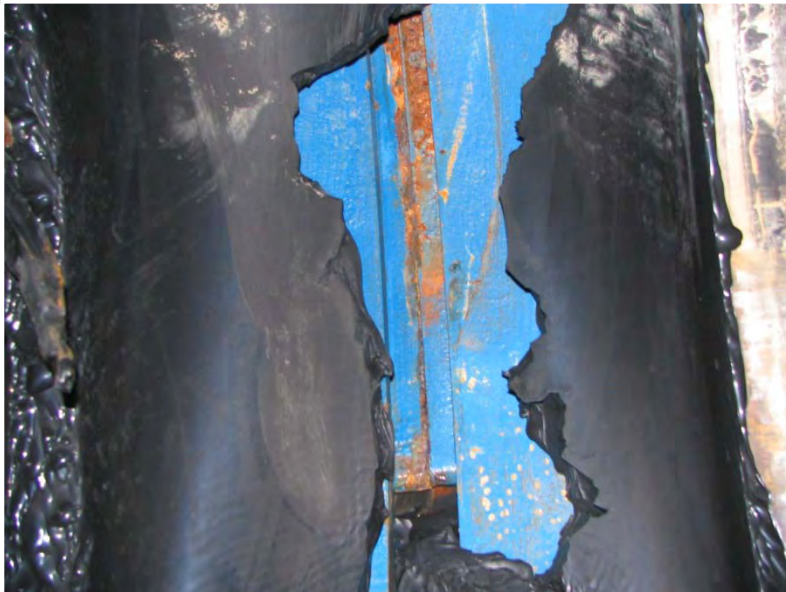
# AR Pump Rubber Liner Failure

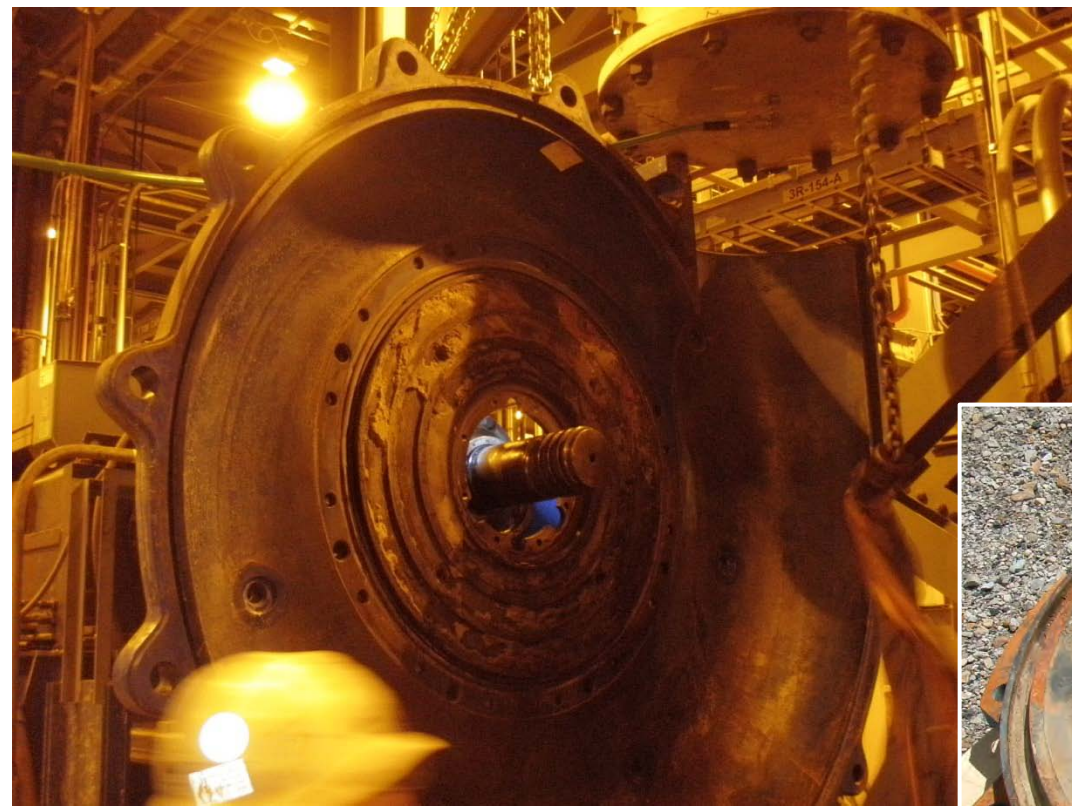
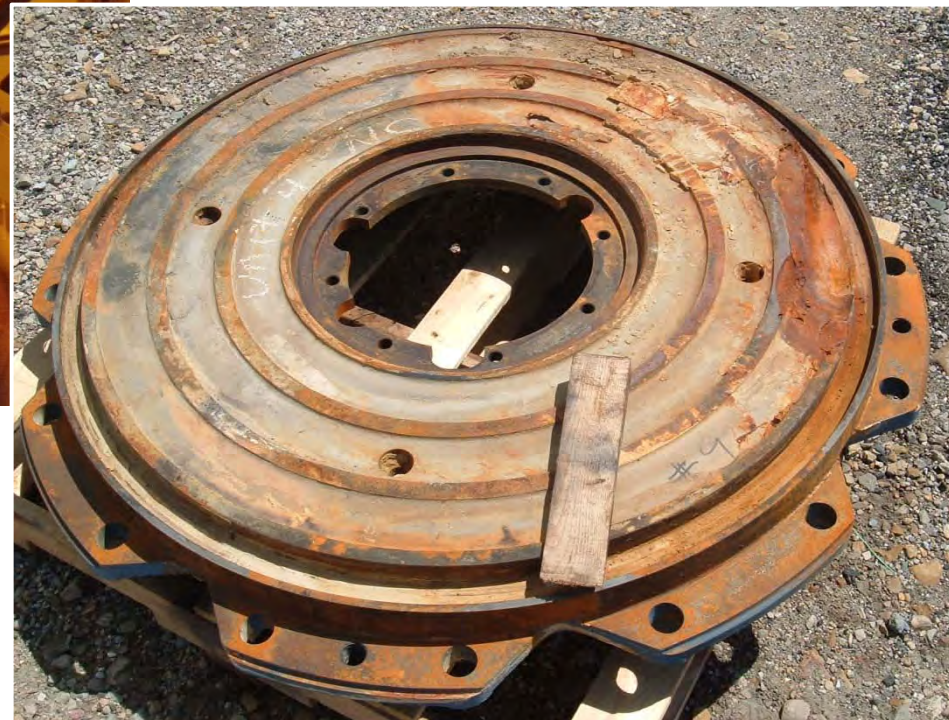
# AR Pump Rubber Liner Failure

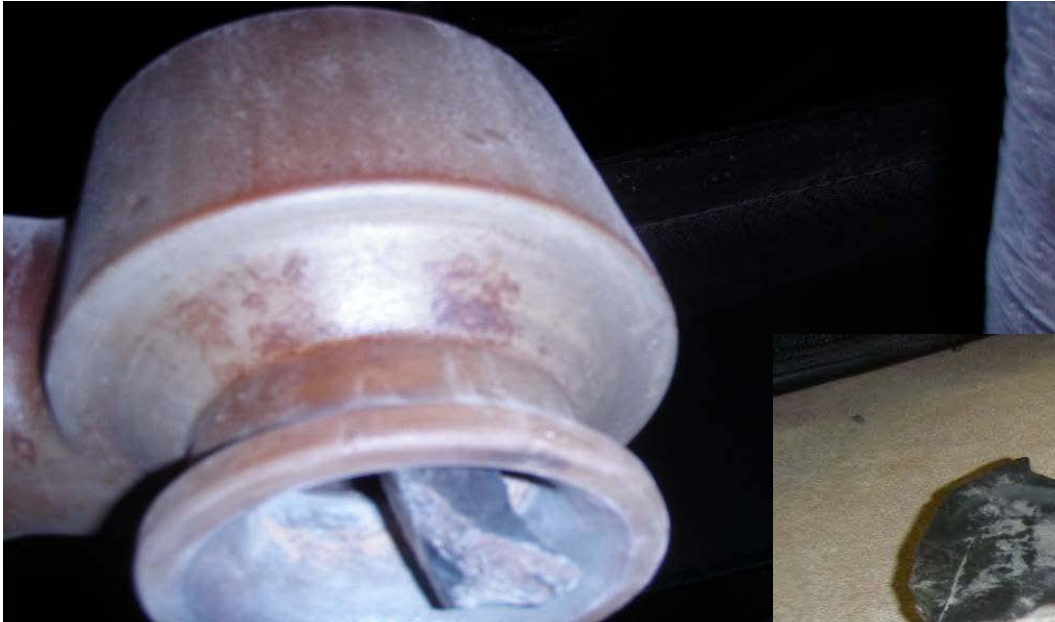
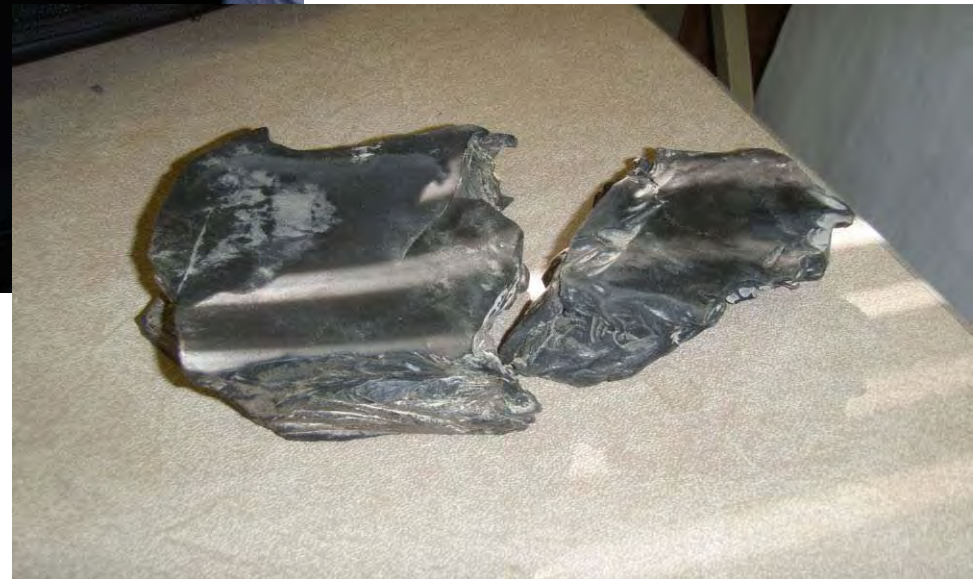
# AR Pump Rubber Liner Failure

- ▶ Rubber plugging nozzle

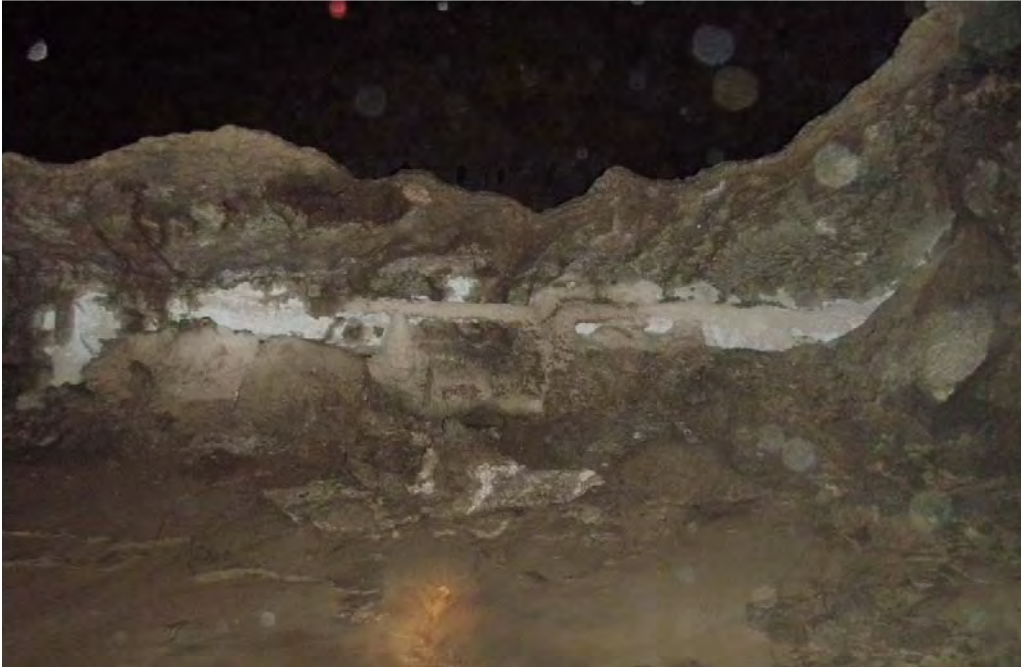
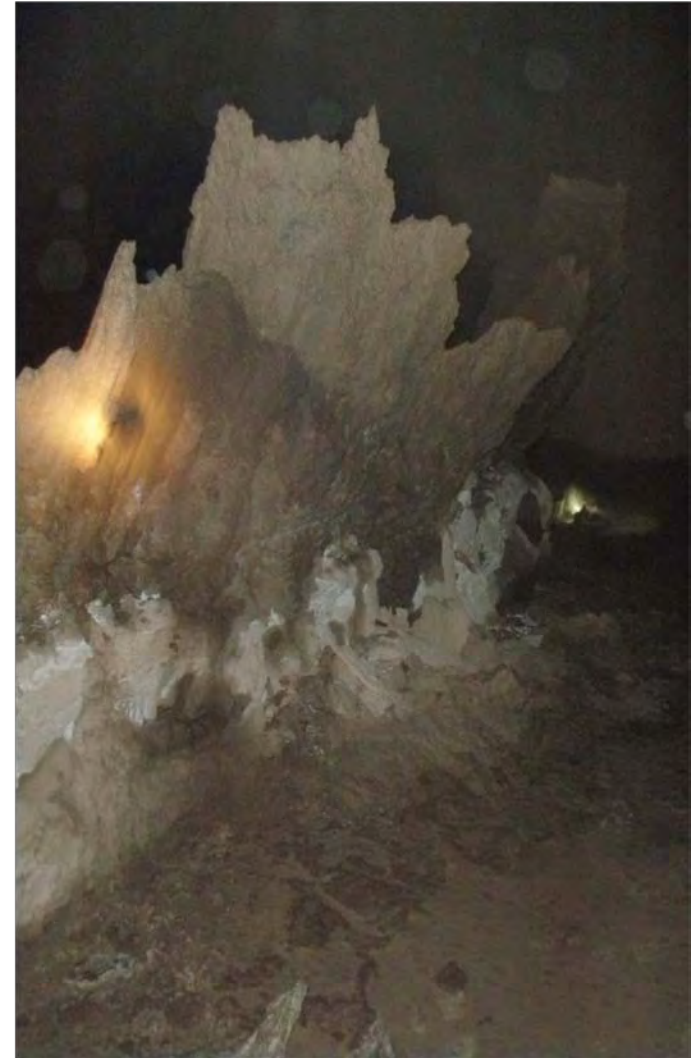
# Inlet Buildup

- **Buildup is several feet high**
- **Accumulates on handrail**

- ▶ Inlet handrail removed at DTE Monroe
- ▶ Solids buildup has been greatly reduced since removal

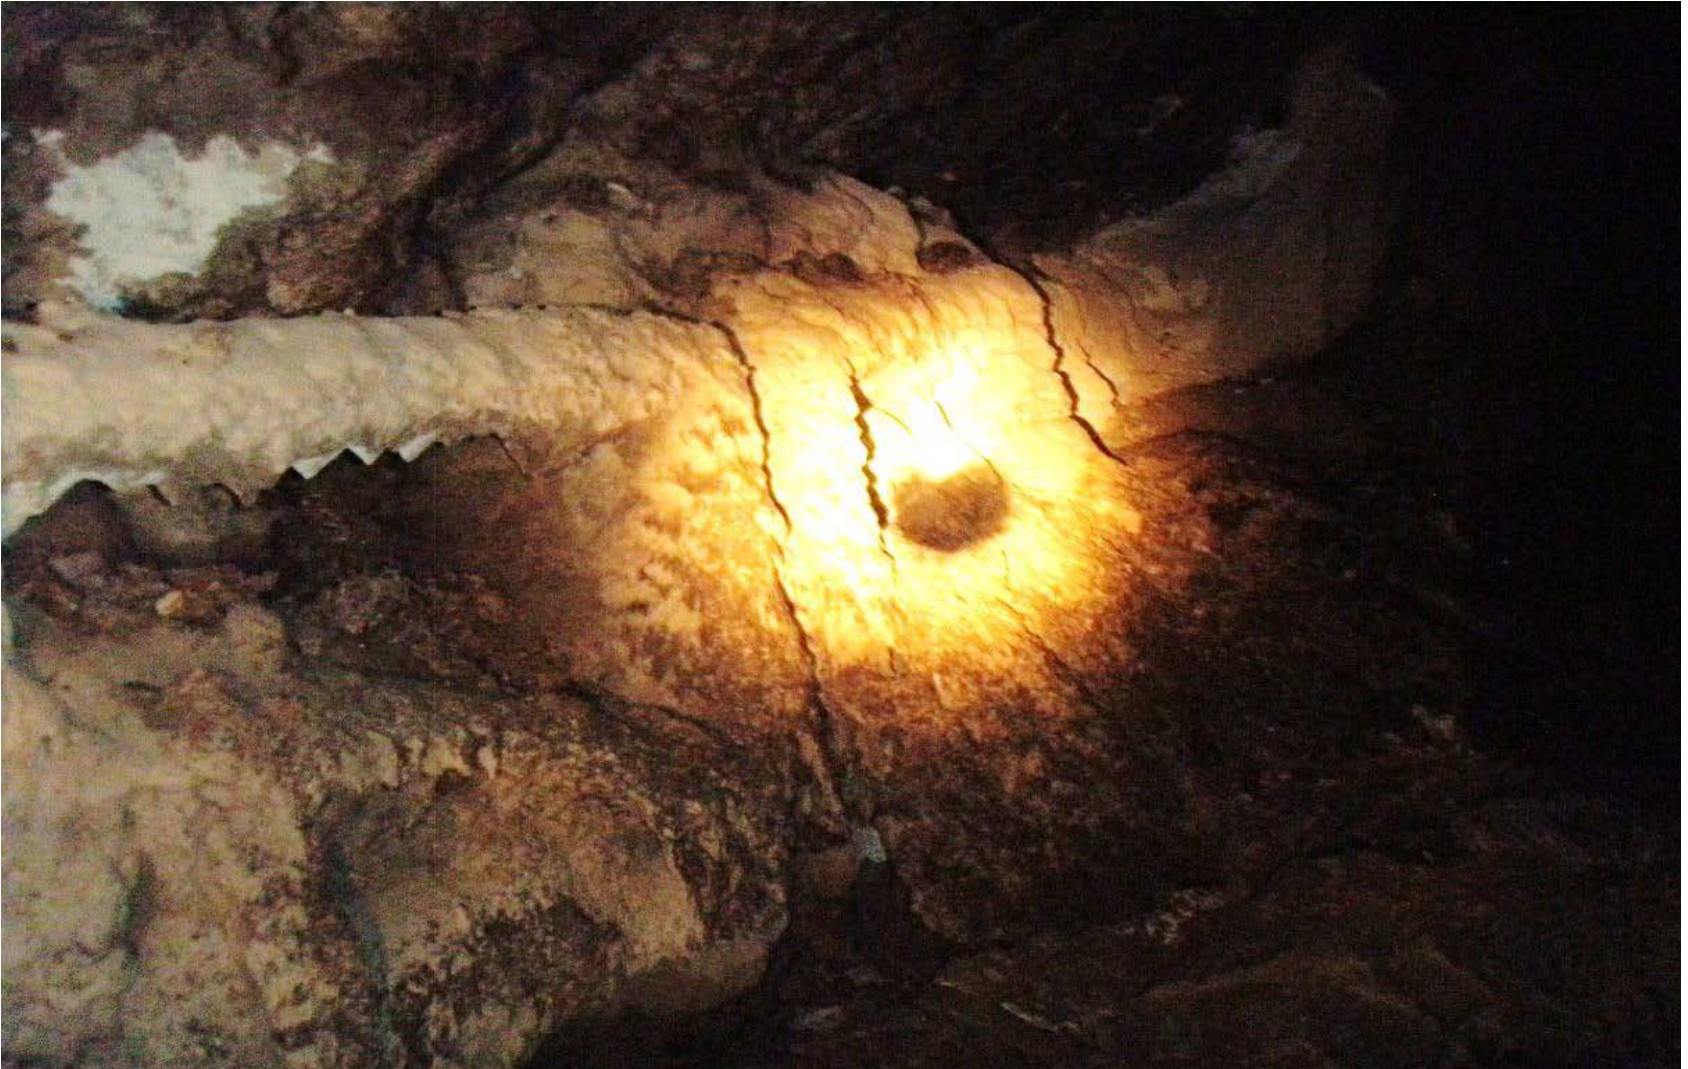
# Buildup on Inlet Handrail

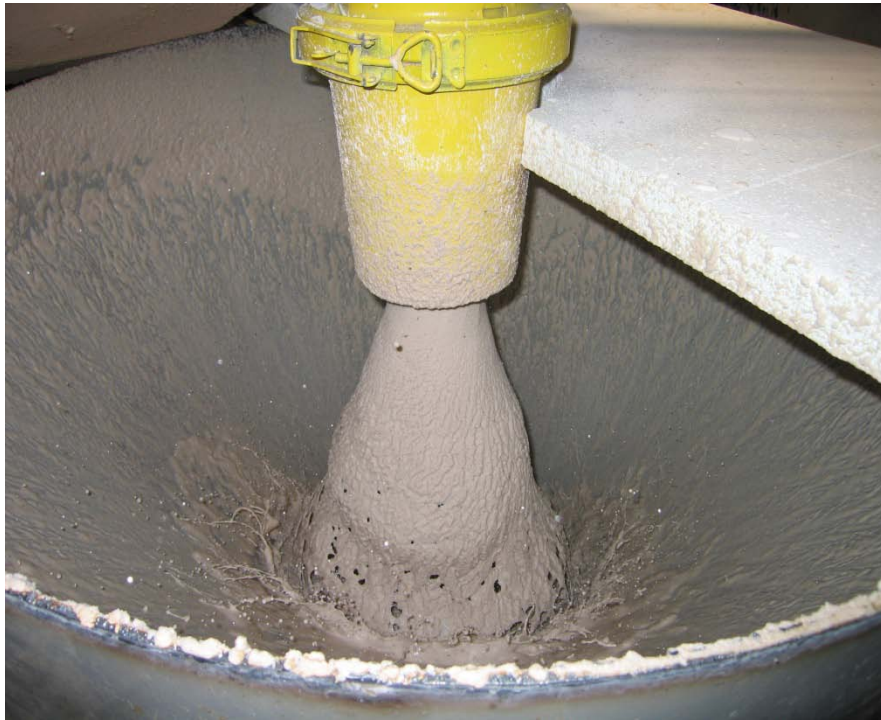
**Good Underflow Pattern**

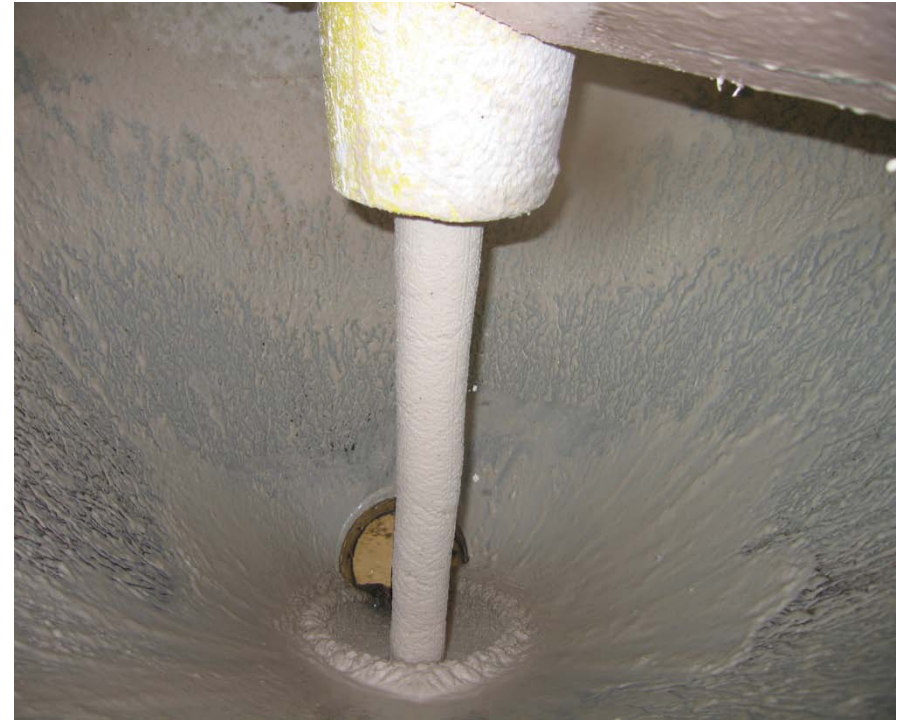
**Roping – Potential Plugging**

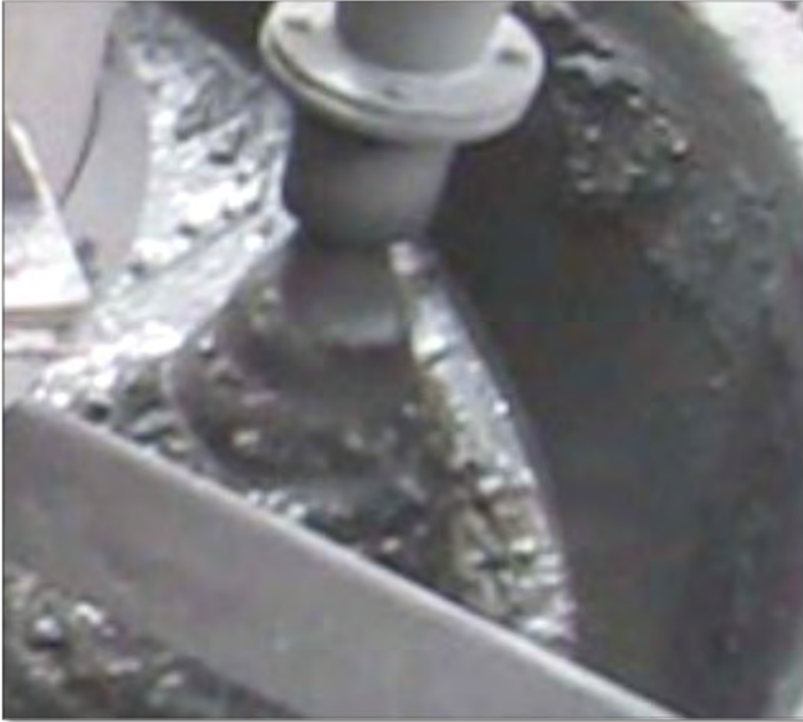
**Wide Angle Indicates Worn Apex**

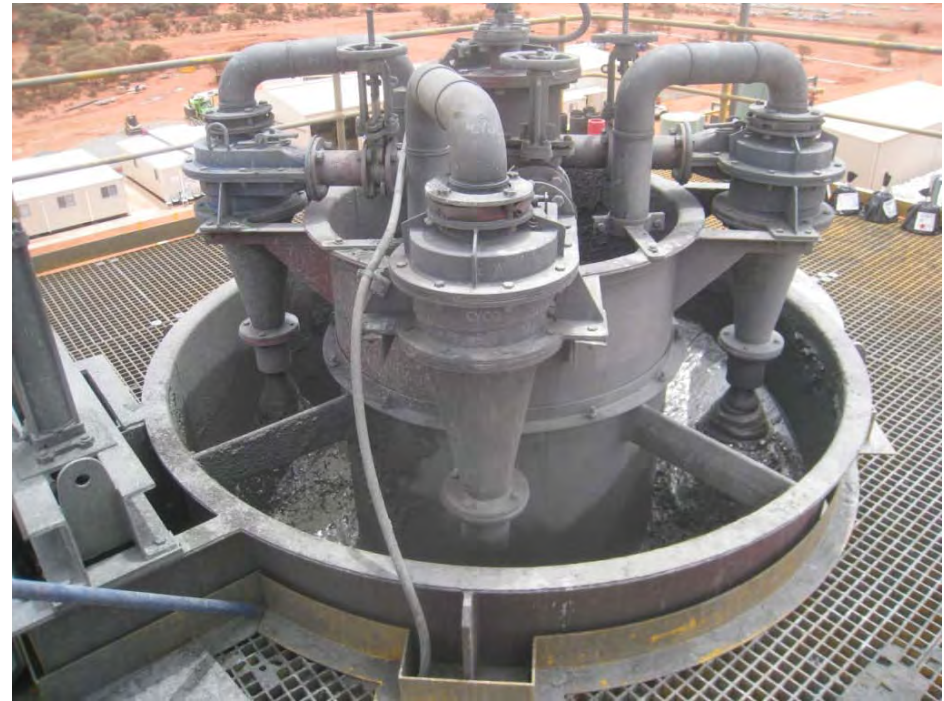
**Hard Inlet Scale May Prematurely Wear Apexes**

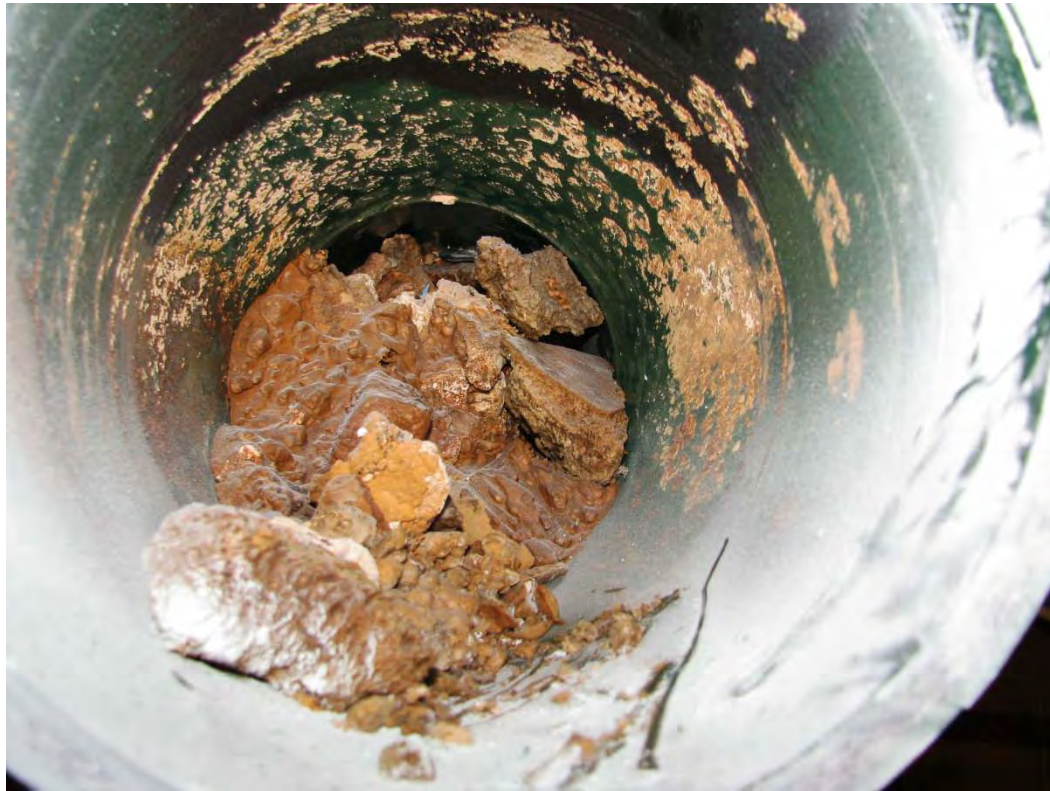
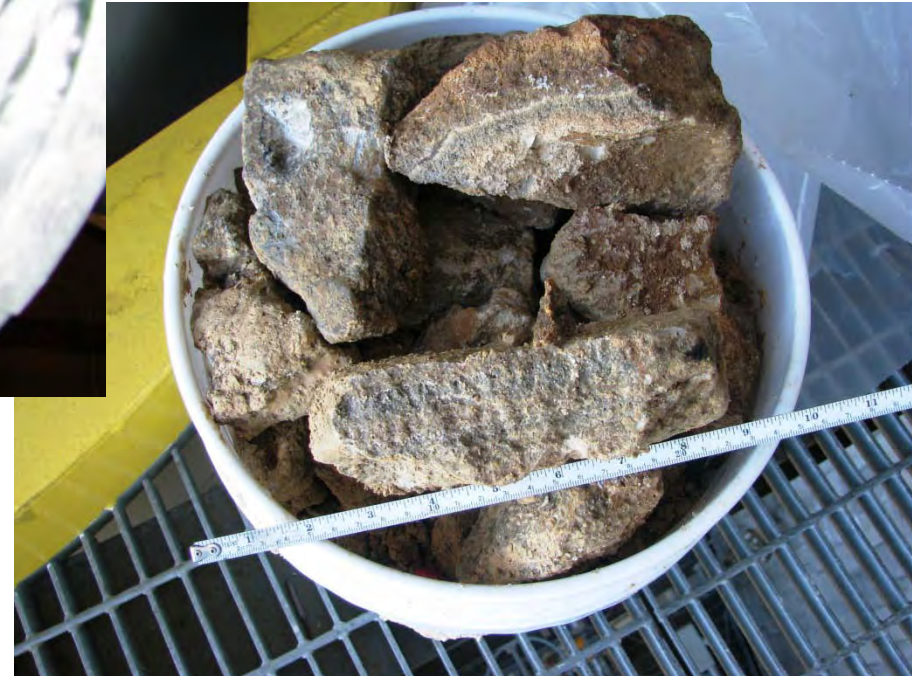
# Spray Header Plugging from Inlet Buildup

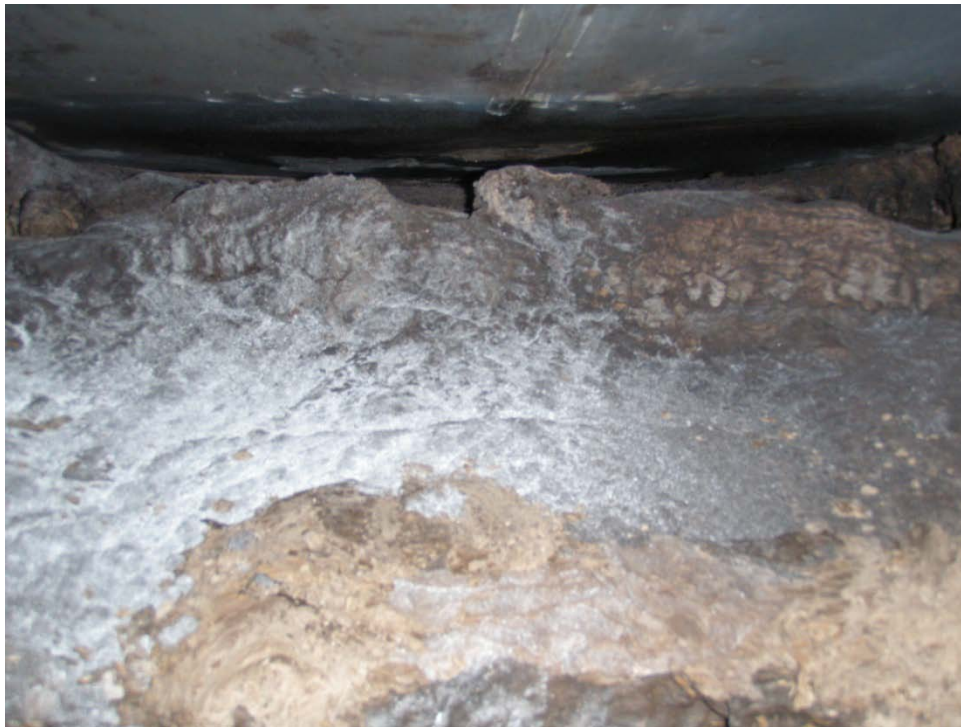
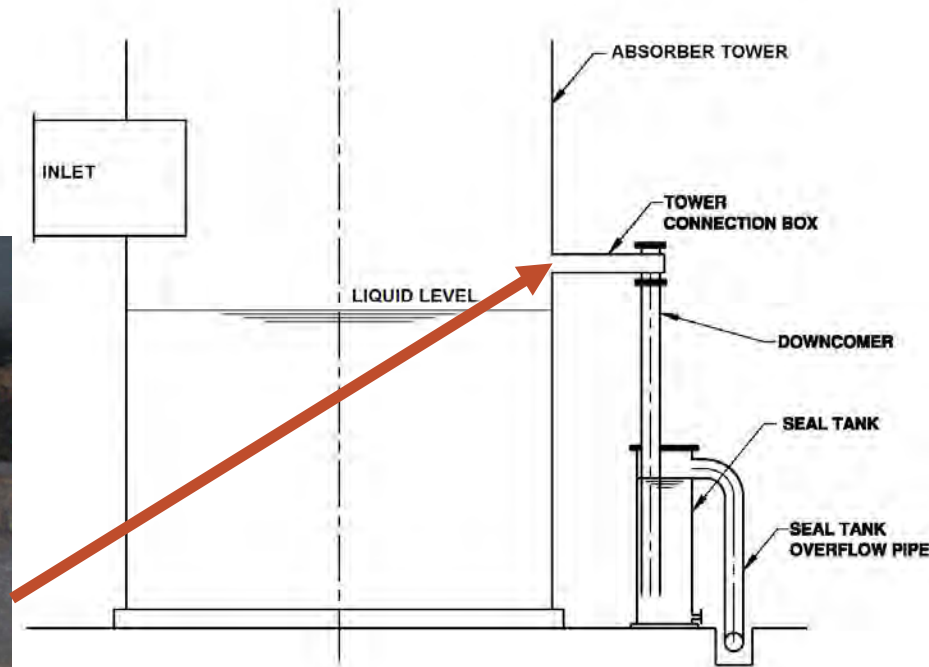
- Slurry solids accumulation in tower overflow connection box
- Did not allow overflow to drain out of tower

- Spray nozzle installed in overflow connection box
- Periodically sprays water to wash-off solids deposits
- Overflow plugging not experiences since wash nozzle installed

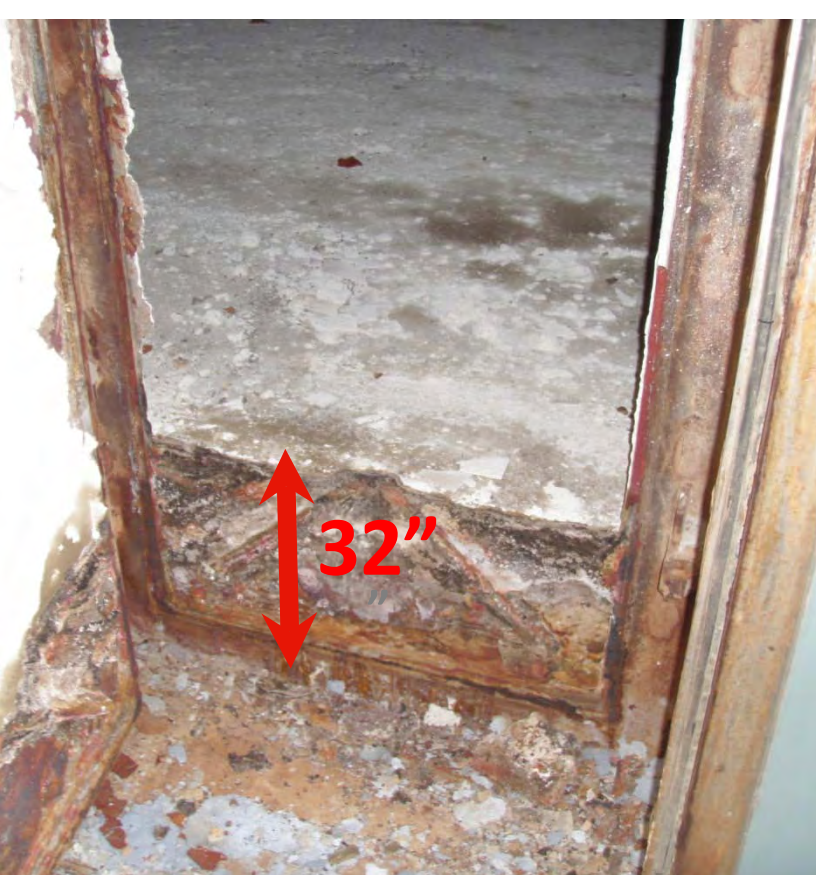
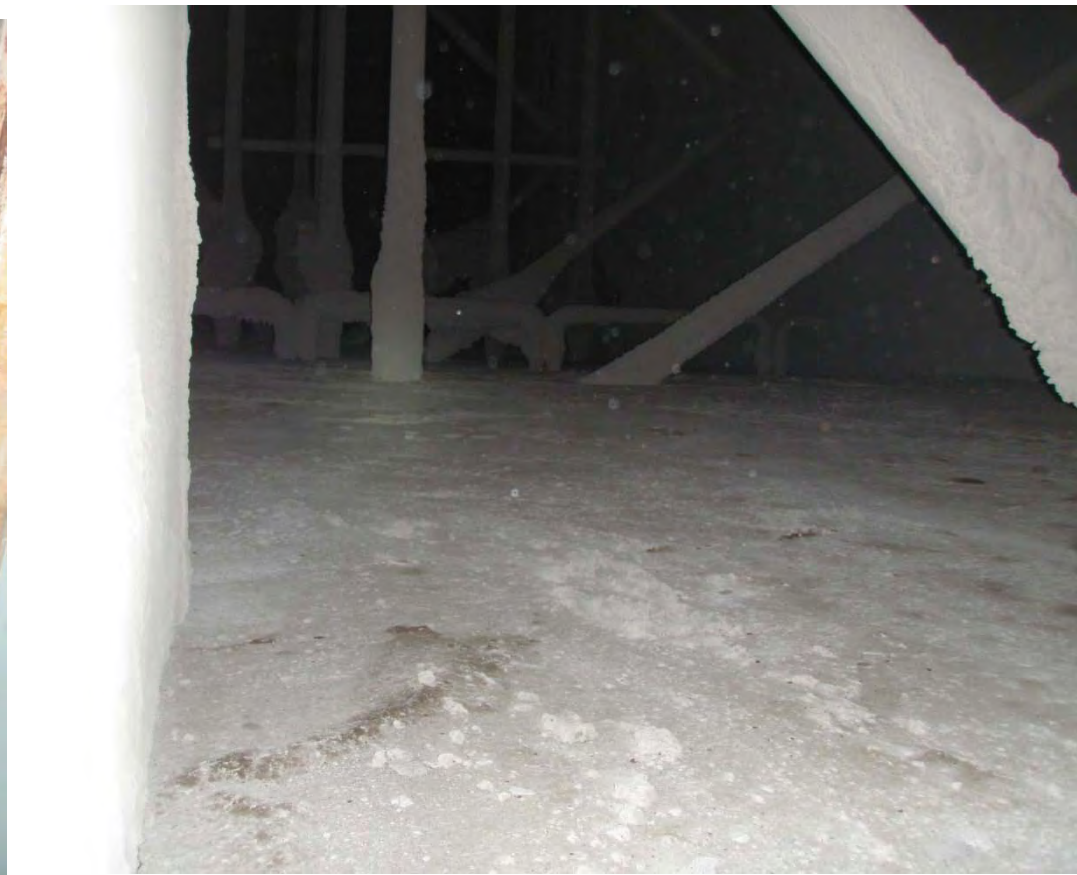
- **Blocked overflow caused slurry to flow into absorber inlet**
  - Inlet drain connections were plugged
  - Approximately 32" of material accumulated on floor of inlet

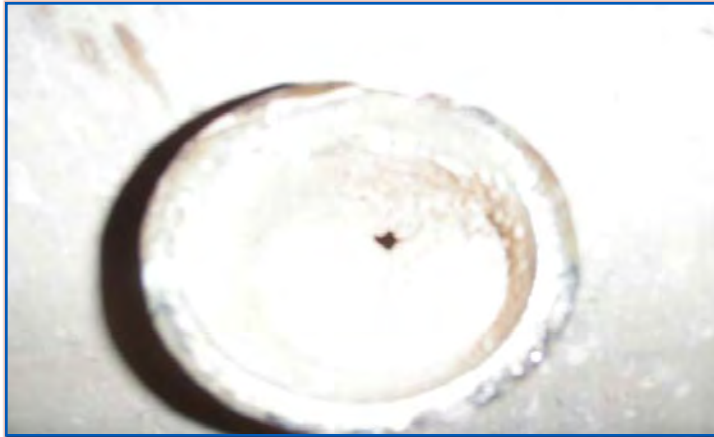
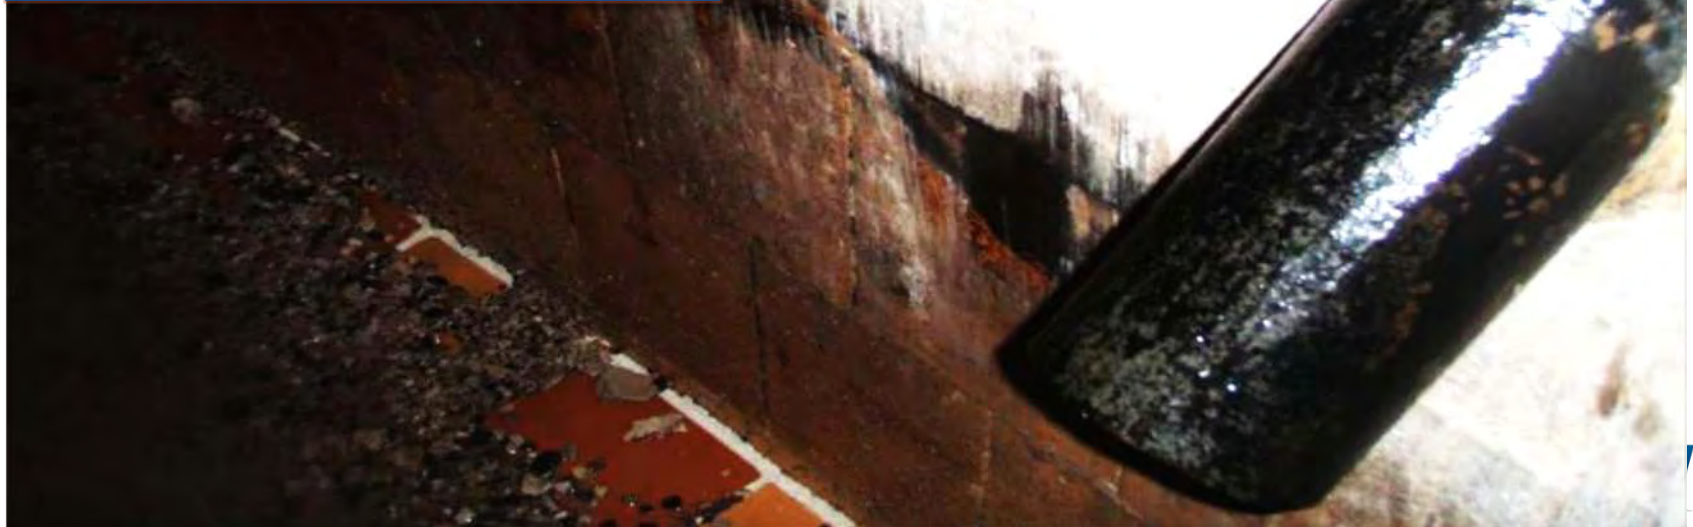
- ▶ Level measurement difficulty
  - Solids buildup on absorber floor
- ▶ Flush Connection Added
  - Flush water used to clear connection

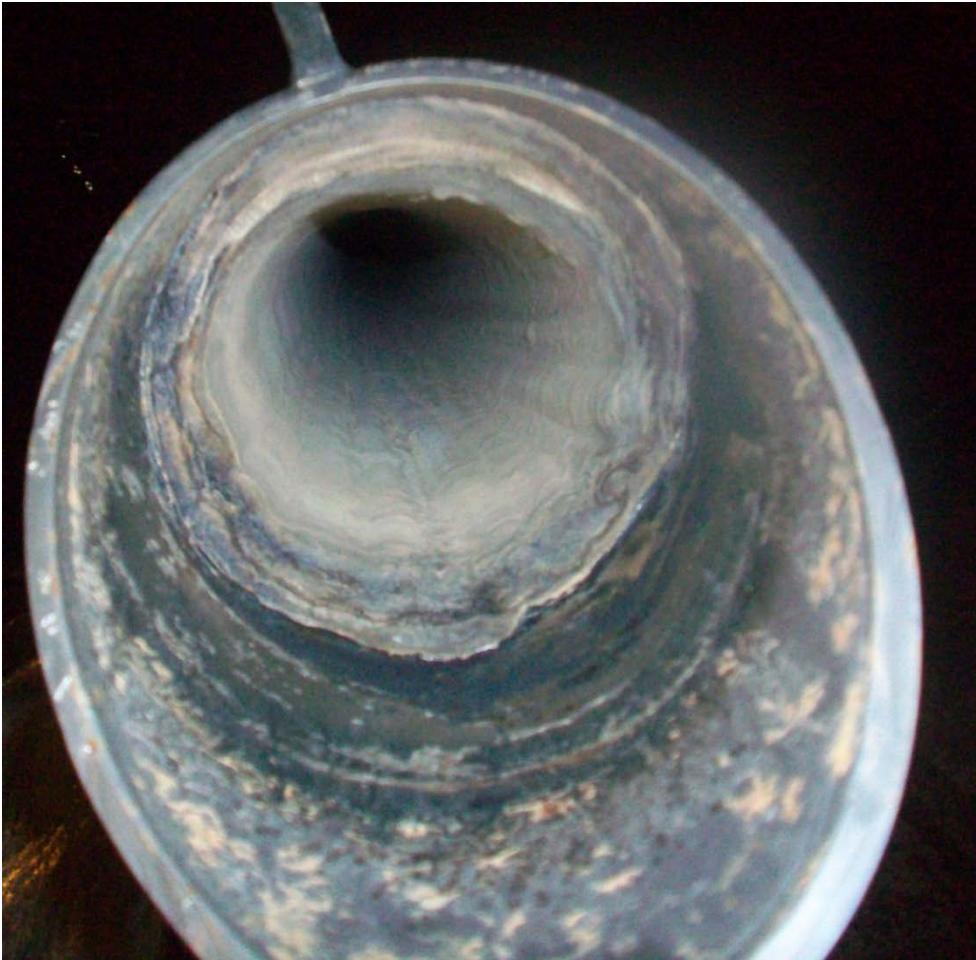
- ▶ Most oxidation air lances experience plugging

- ▶ Severe cases have 1" to 2" opening or completely plugged off
- ▶ Possibly due to:
  - Low lance air velocity when turning down air flow
  - Incomplete humidification
  - Impurities in humidification water
  - Chemistry upsets
  - Recirculation eddies in lance

- ▶ Individual lance airflow measurements
  - Detect plugged lances
- ▶ Humidification water to each lance:
  - Control water pressure
  - Spray nozzle for each lance
  - Strainer in humidification water piping
