## **2016 APC-Wastewater Round Table & Expo Presentation**

# Wet FGD Operations and Lessons Learned

Joe Mitchell, *Environmental Process Engineer*

# WFGD Operations and Lessons Learned – Monroe Station

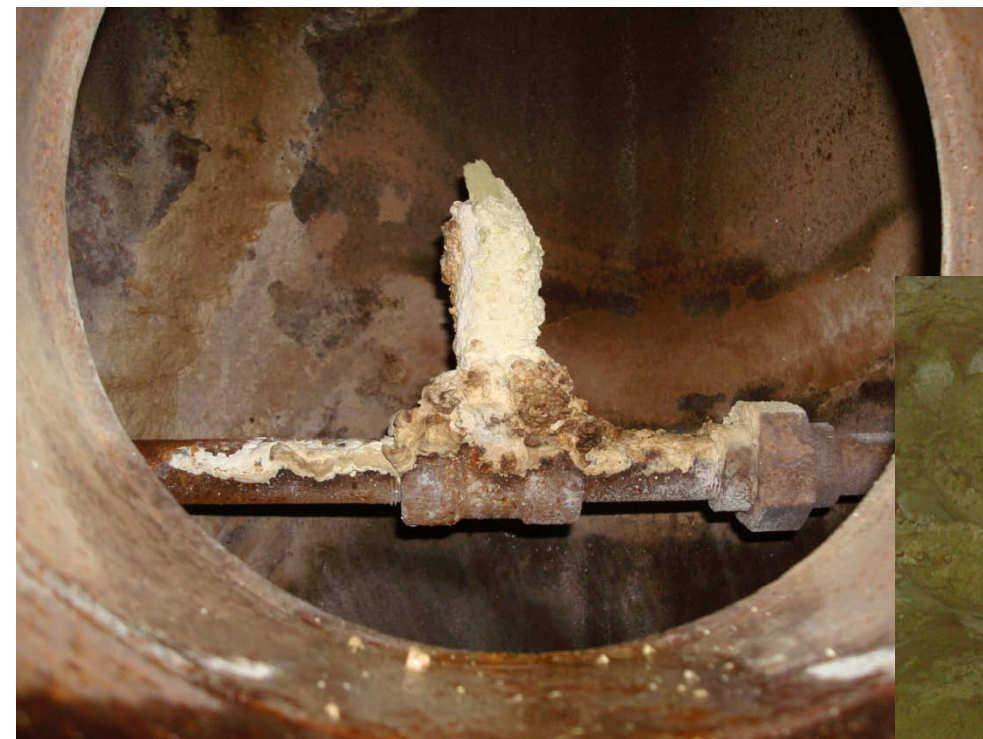
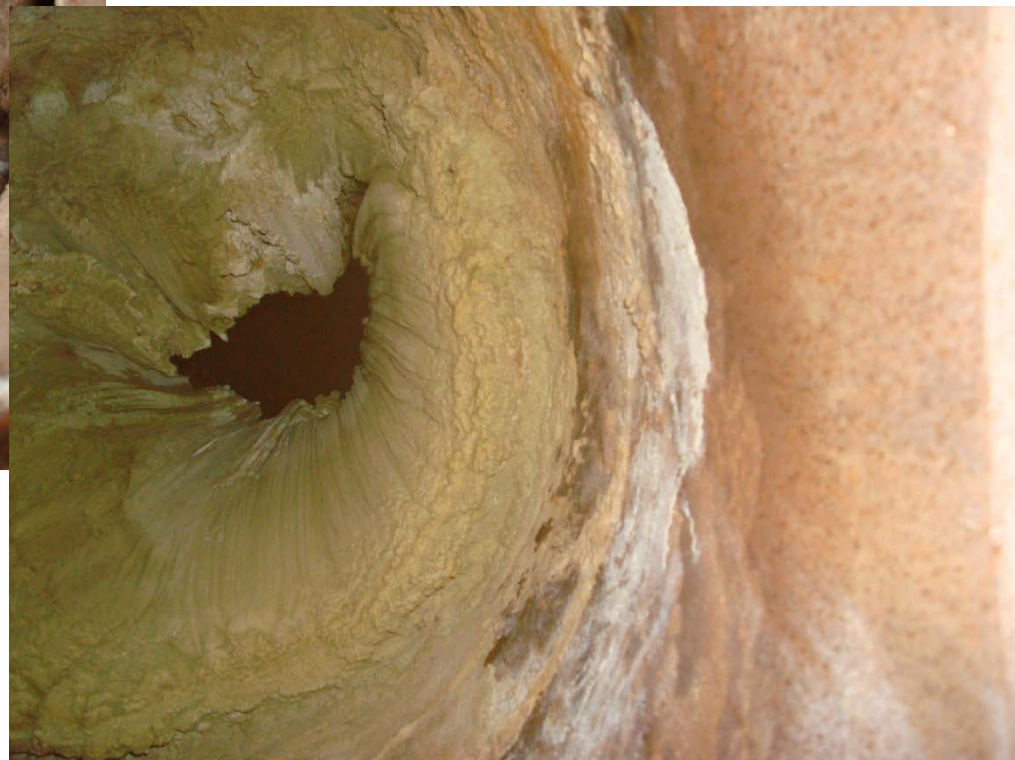
- ▶ Poor chemical properties such as high TDS and High hardness can cause scaling problems on the ME blades, in the Oxidation Air piping and in the belt filter system vacuum pump.
- ▶ High solids content can leave deposits on the ME blades, in the oxidation air piping and in the vacuum pumps. Additionally, high suspended solids can cause plugging of the ME wash nozzles and plugging of any water cooled heat exchangers.

# Oxidation Air Pipe Scaling at Humidification Spray Nozzle

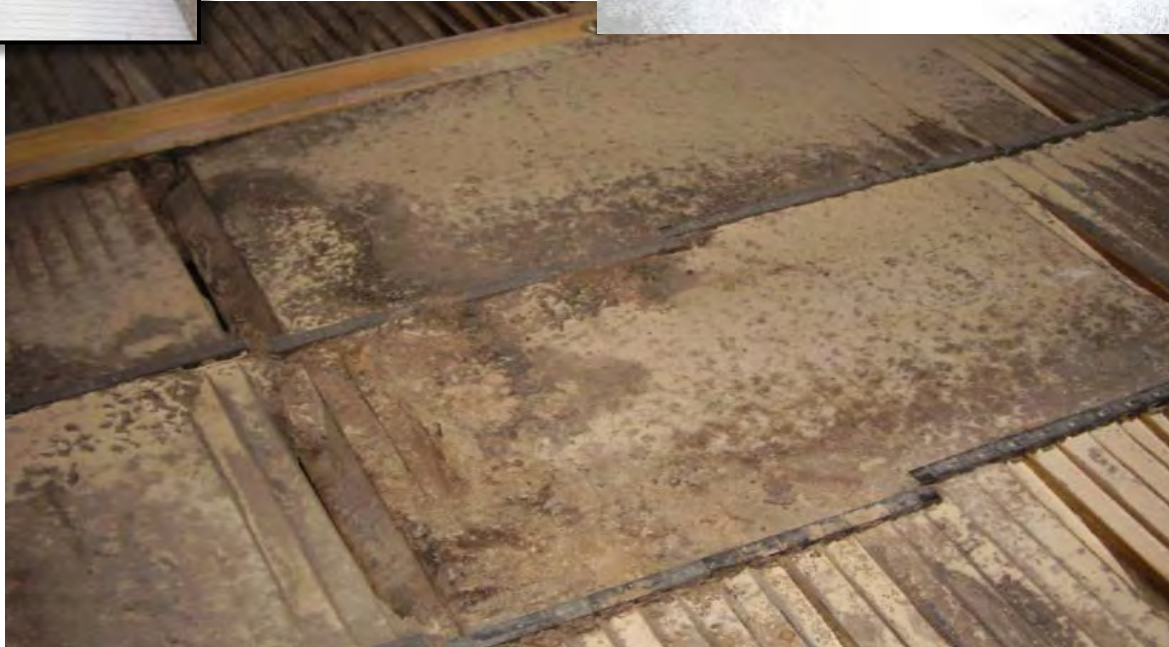
# Wash Nozzle Plugging – ME plugging
