## **2016 APC-Wastewater Round Table & Expo Presentation**

# Wet FGD Operations and Lessons Learned

Joe Mitchell, *Environmental Process Engineer*

# WFGD Operations and Lessons Learned – Monroe Station

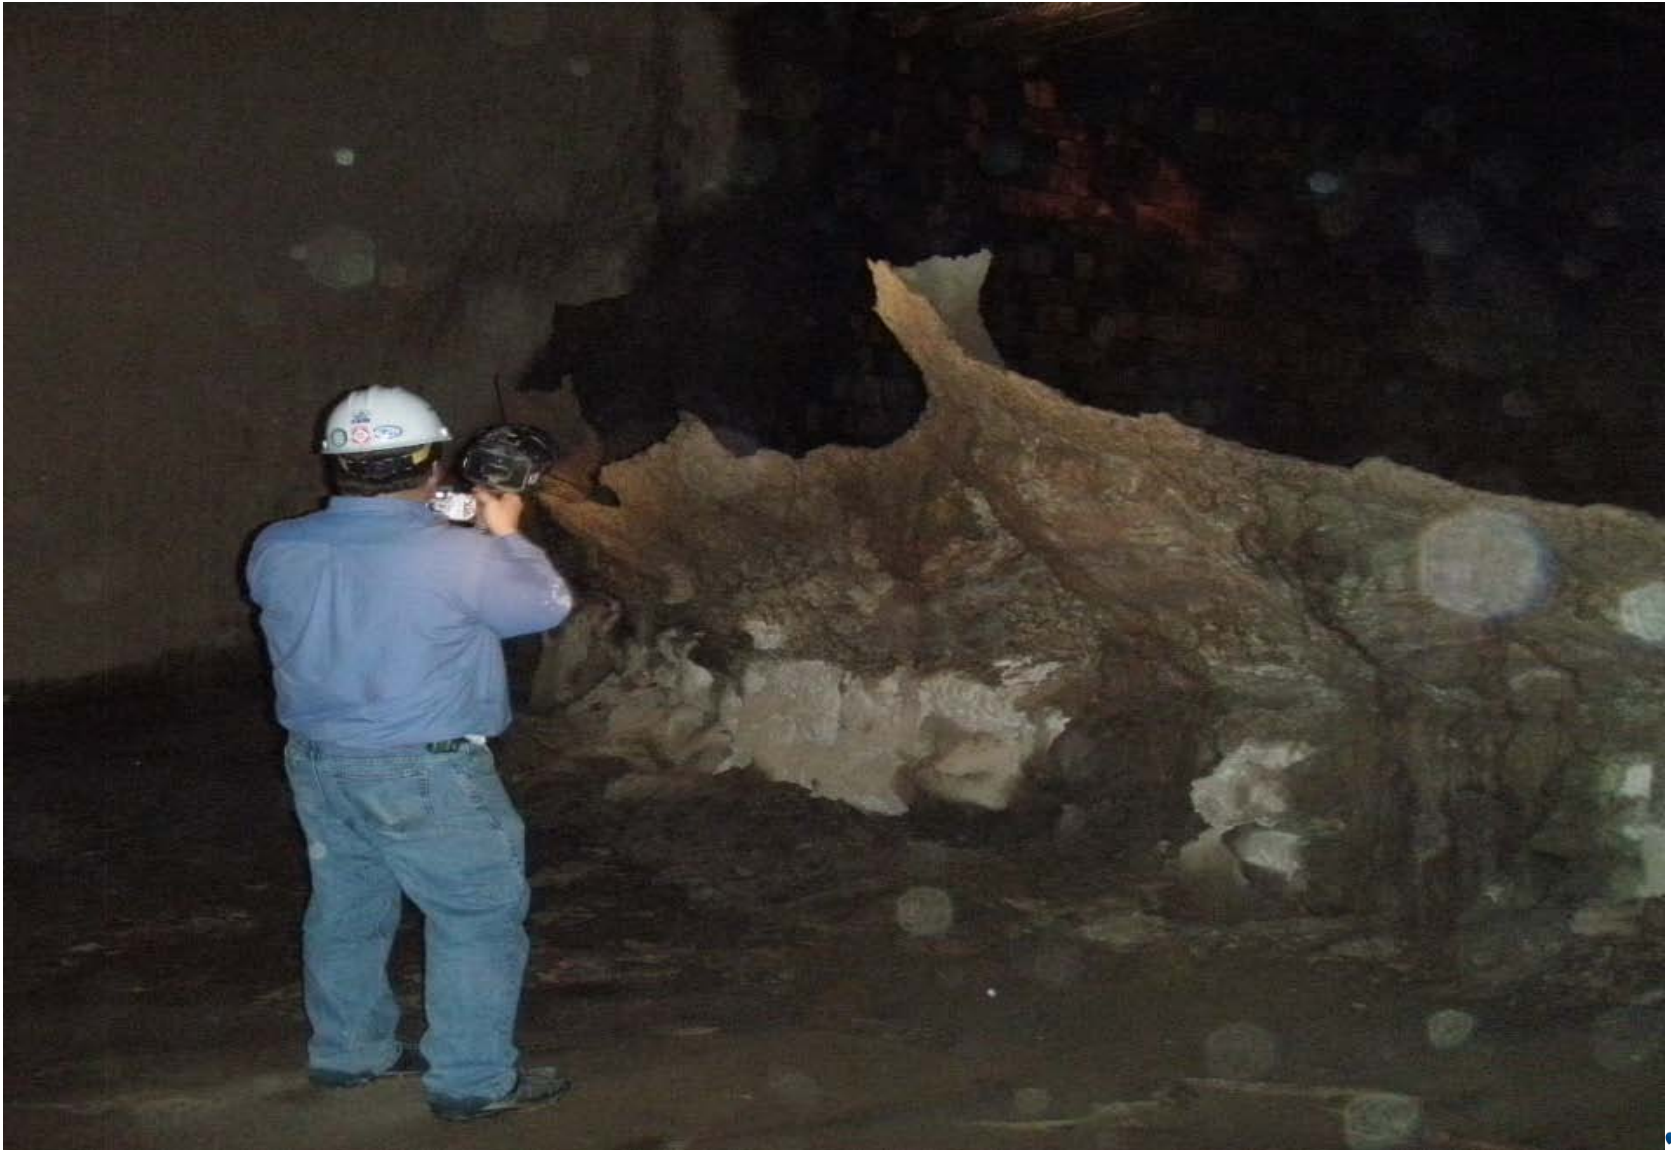
# Inlet Buildup

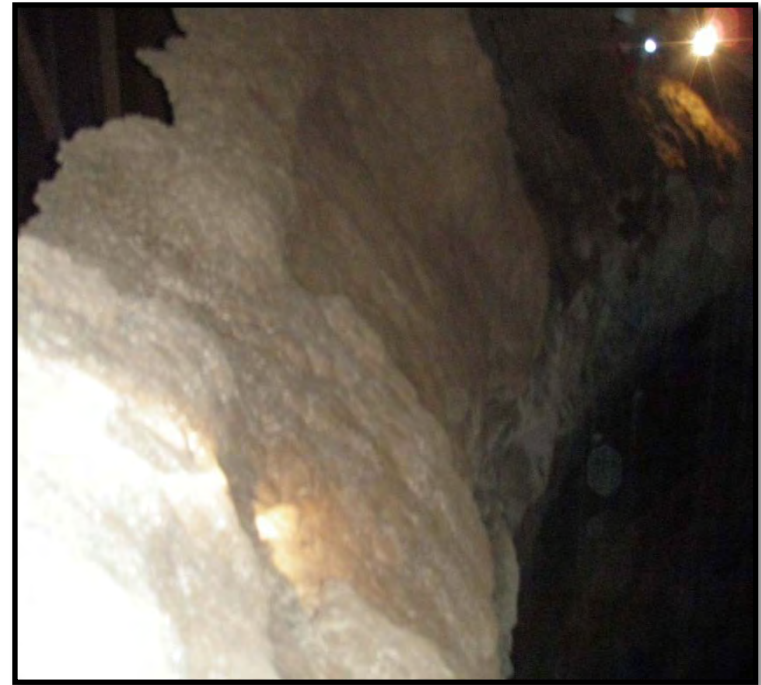
## Inlet Buildup in LFSO WFGD System

- ▶ Observed in several WFGD installations across multiple Utilities
- ▶ Low load operation allows surface waves in tower to “lap” into the inlet
- ▶ Eddies in the flue gas flow are formed at the side edges of the inlet as the gas passes from the gas inlet to the interior of the WFGD tower

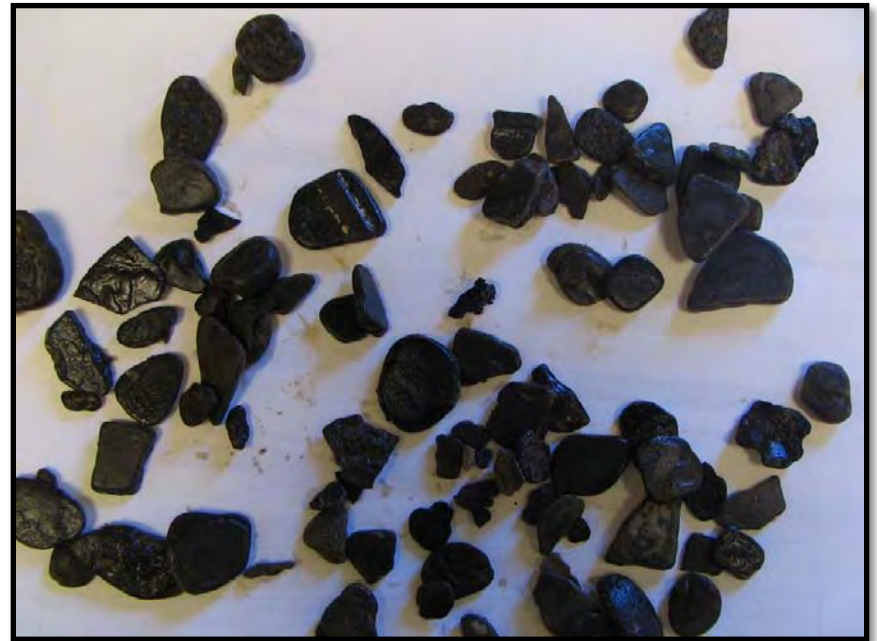
- ▶ Deposits are mainly gypsum, gypsum hemi-hydrate, and anhydrite (dehydrated gypsum)
- ▶ The inlet deposits are not rehydrated in slurry, so large pieces break off and are drawn through the pumps
- ▶ Excessive buildup may shed due to thermal cycles (startup/shutdown and load cycling), or by gravity into absorber reaction tank at intervals
- ▶ Major source of hydroclone pluggage, excessive pump wear & header pluggage

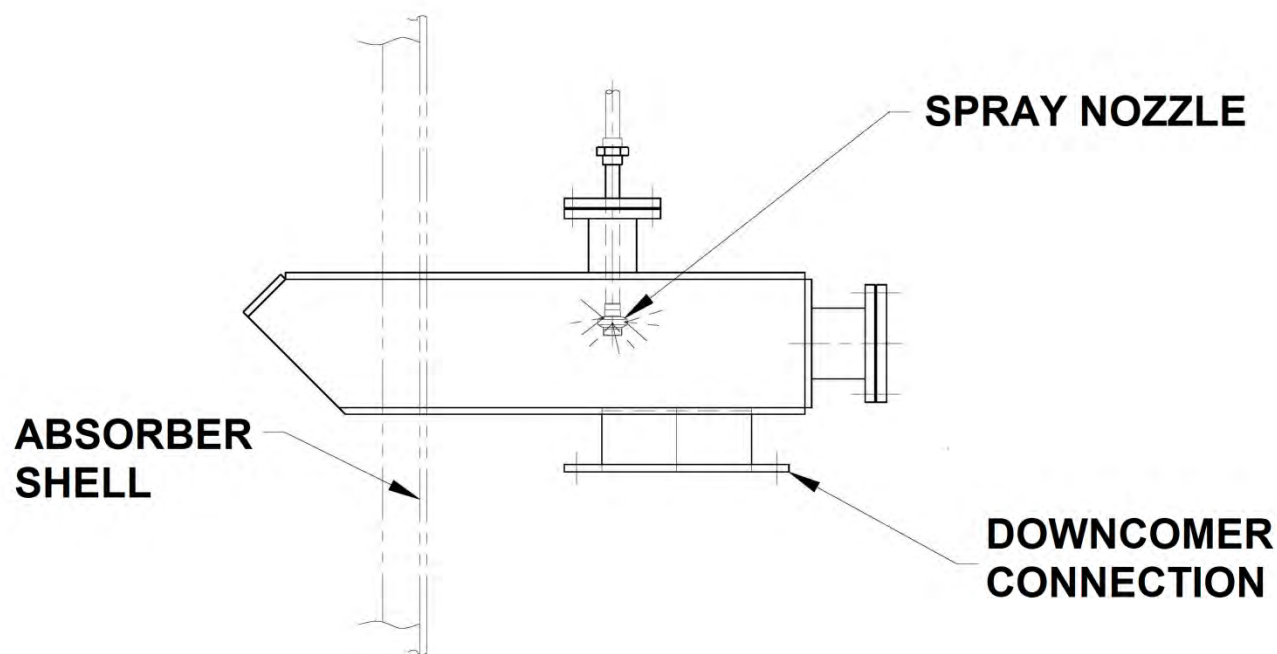
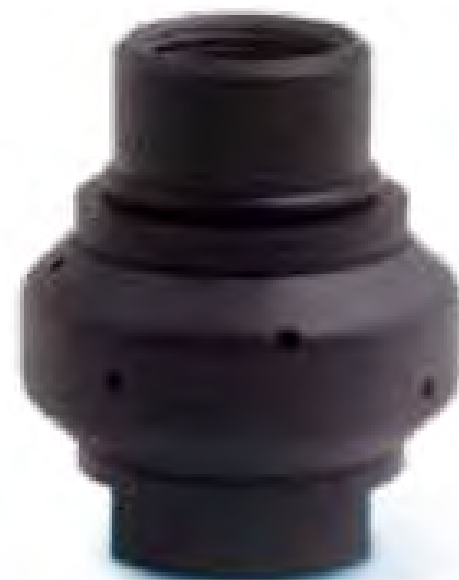
- **Blocked overflow caused slurry to flow into absorber inlet**
  - Inlet drain connections were plugged
  - Approximately 32" of material accumulated on floor of inlet

- Spray nozzle installed in overflow connection box
- Periodically sprays water to wash-off solids deposits
- Overflow plugging not experiences since wash nozzle installed

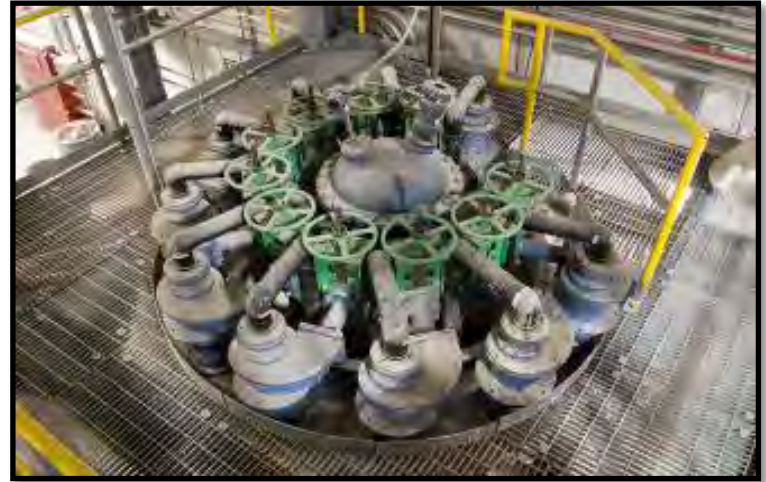
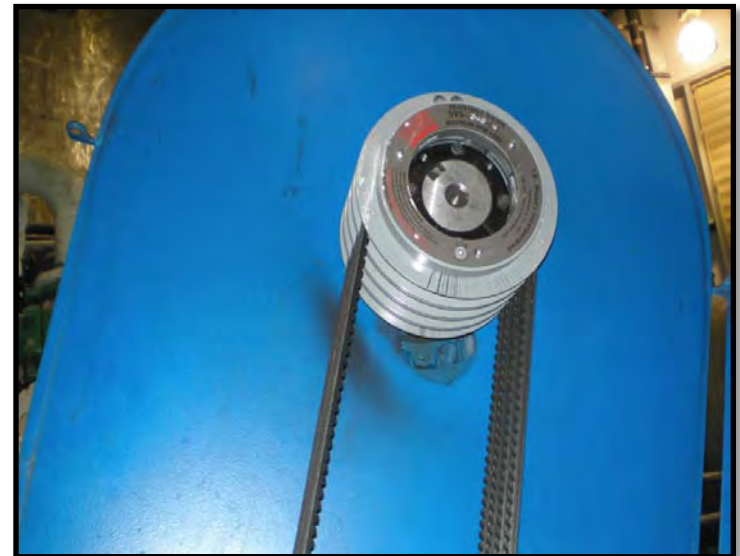
- **Density control difficulty with high S fuel**
- **Pump speed set too low to maintain %TSS setpoint**
  - Adjustable sheaves set to slowest speed
- **%TSS reached high set point and even with continuous bleed to the hydroclones did not decrease**
- **Pump sheaves replaced to increase pump speed with higher margin above maximum bleed required**

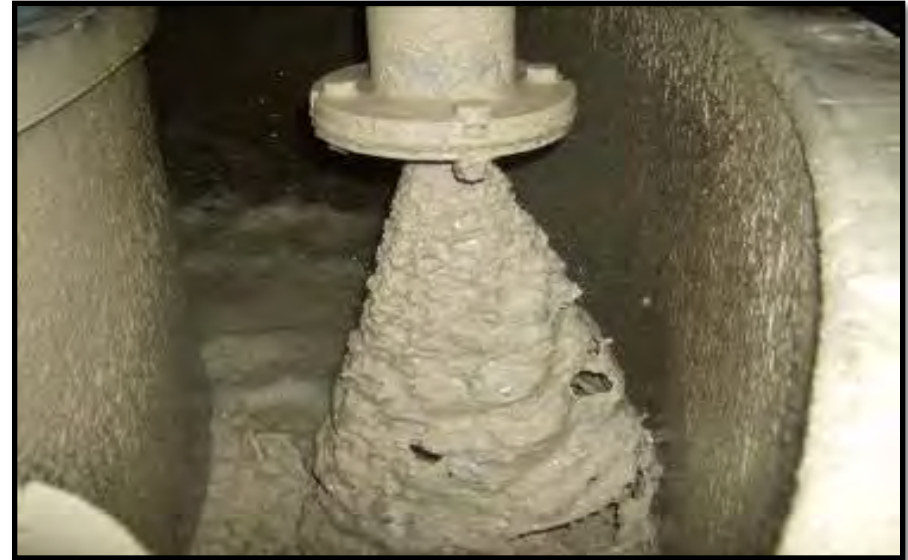
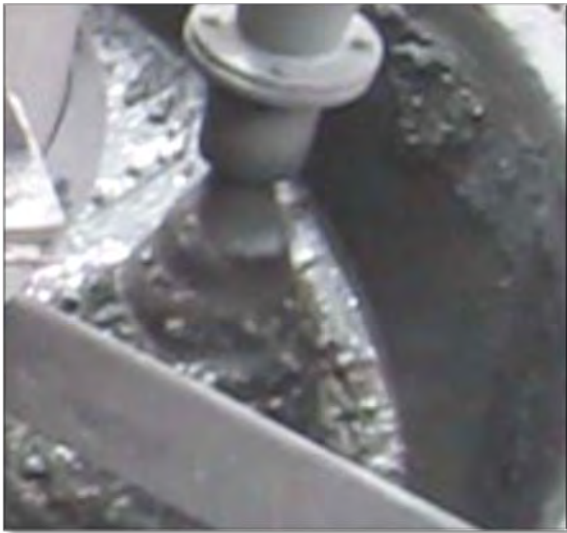
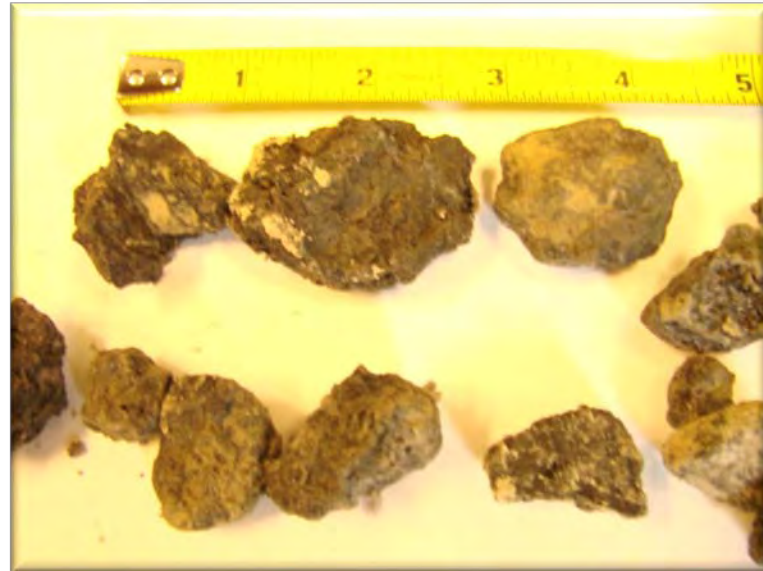
- Possible that debris contributed to challenges
- Higher dP in hydroclone while plugged with solids

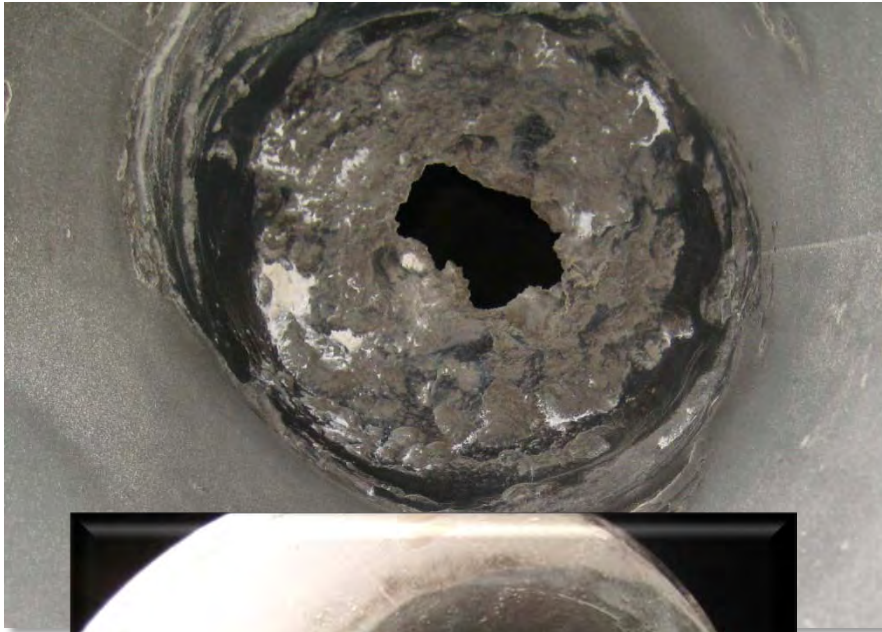
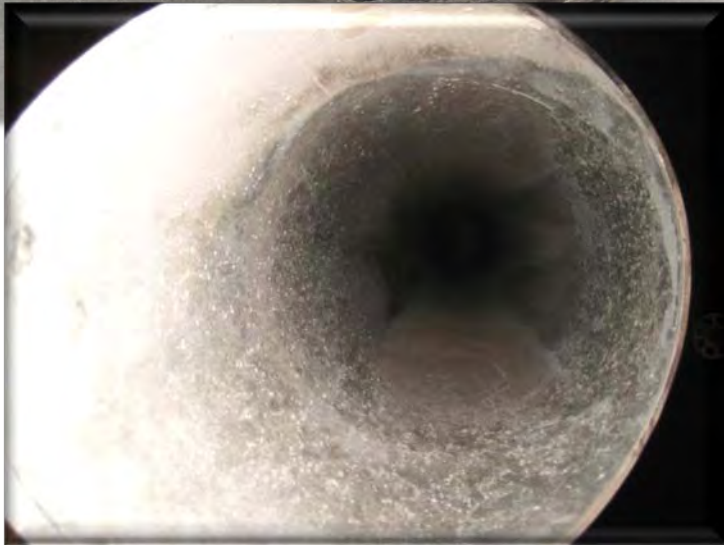
- ▶ Severe cases have 1" to 2" opening or completely plugged off
- ▶ Possibly due to:
  - Low lance air velocity when turning down air flow
  - Incomplete humidification
  - Impurities in humidification water
  - Chemistry upsets
  - Recirculation eddies in lance

- ▶ Individual lance airflow measurements
  - Detect plugged lances
- ▶ Humidification water to each lance:
  - Control water pressure
  - Spray nozzle for each lance
  - Strainer in humidification water piping

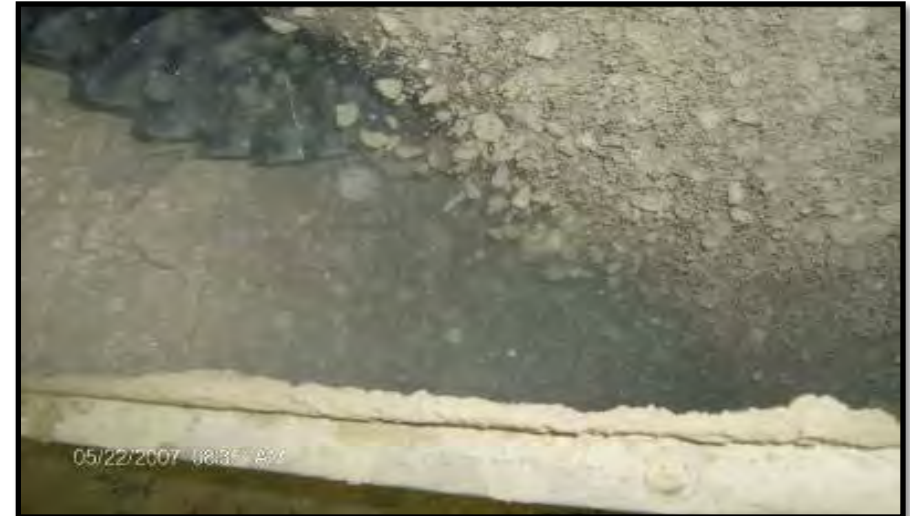
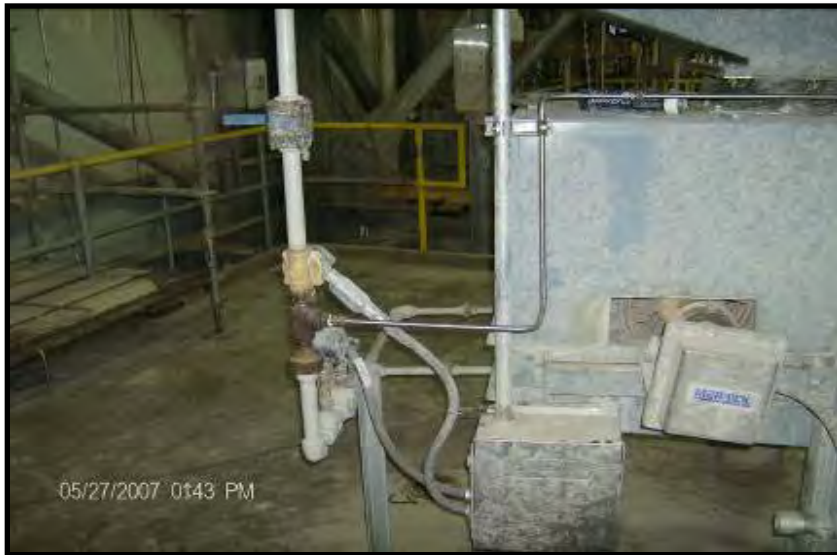
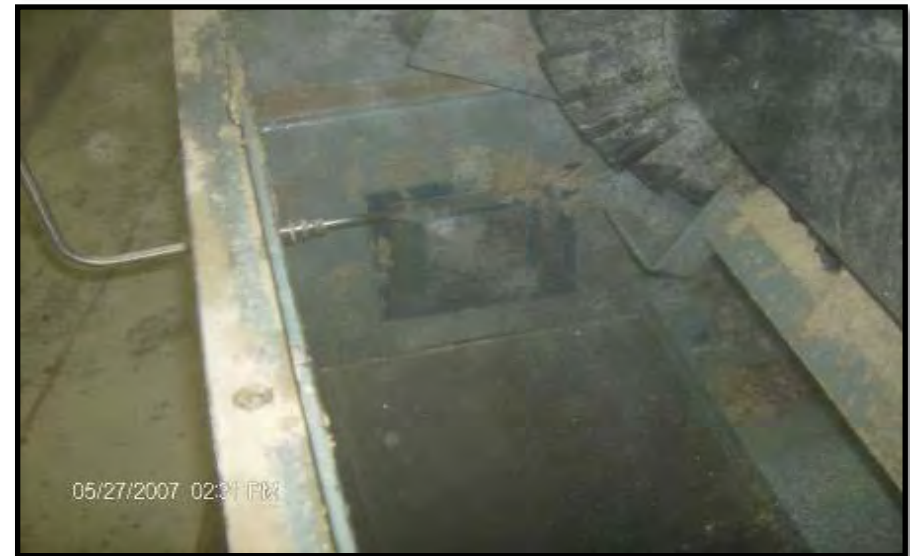
- Historically, system falsely trips w/ fine Limestone
  - Install Flush Line
    - Adds insignificant amount of water to Grinding Side (~2 gpm)
    - Activates only during cleaning cycle

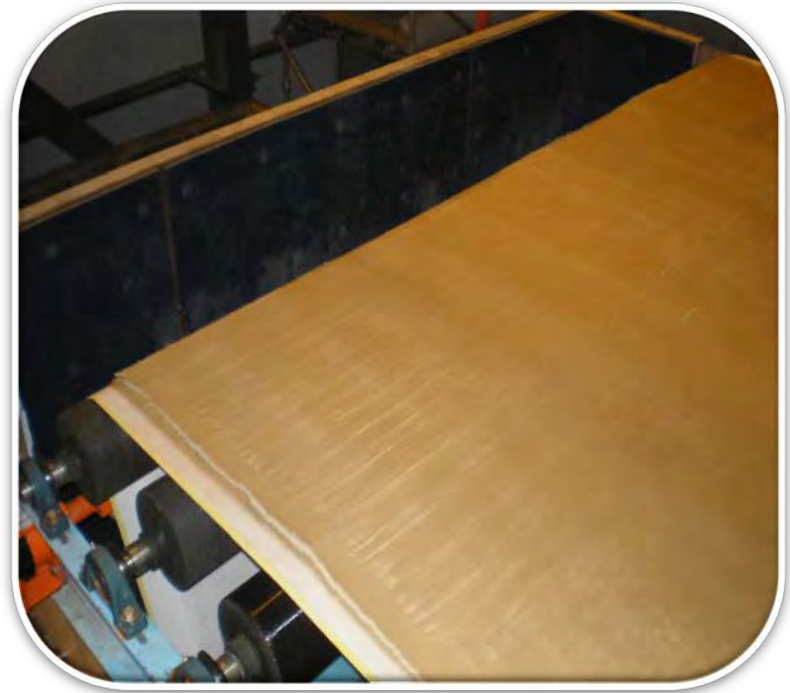
# Vacuum Belts

- ▶ **Setup trends for cake thickness, inerts, and vacuum level**
- ▶ **If system starts to behave outside of range, investigate**
- ▶ **Clean Cloth, ESP operation, hydroclone pluggage**

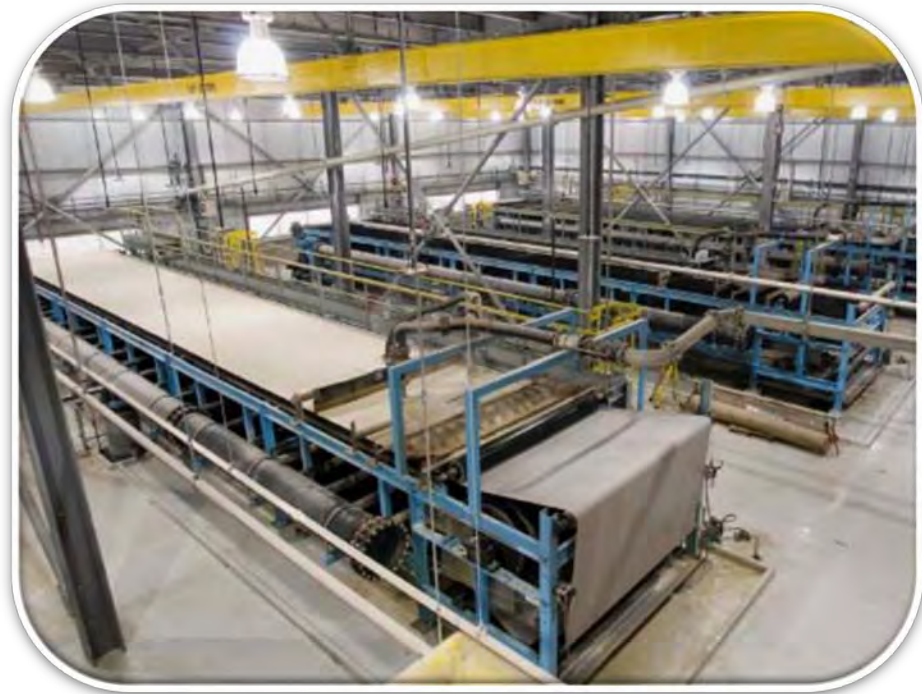
# Vacuum Belt Blinding

- Pressure washing of cloth
- Best to clean underside but can be washed on either side
- Spray from 8"-10" away
- Cleaning can be done spraying the feed end or discharge end
- Can run the filter belt in manual w/ NO PRODUCT for 12hrs. ENSURE lubrication and wash water (40 psi) are on

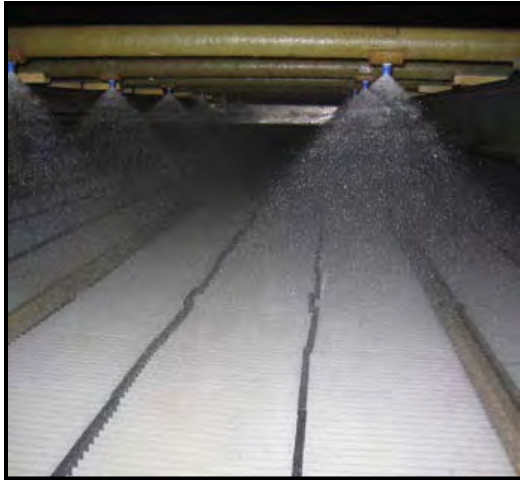
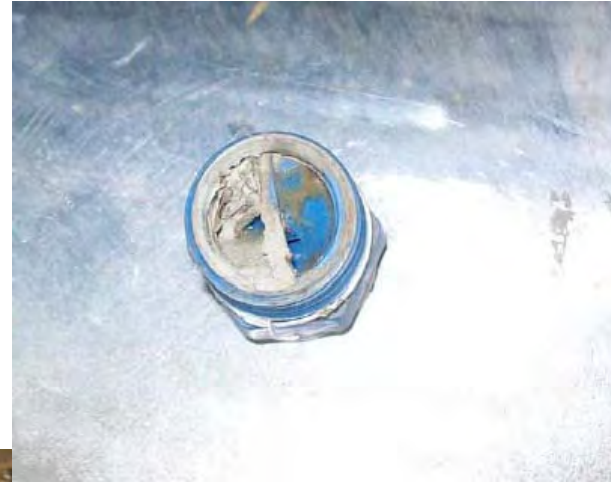
# Wash Nozzle Plugging – ME plugging

- ▶ Poor chemical properties such as high TDS and High hardness can cause scaling problems on the ME blades, in the Oxidation Air piping and in the belt filter system vacuum pump.
- ▶ High solids content can leave deposits on the ME blades, in the oxidation air piping and in the vacuum pumps. Additionally, high suspended solids can cause plugging of the ME wash nozzles and plugging of any water cooled heat exchangers.
